Dr. Maria Andreadaki – Vlazaki
Secretary General
Ministry of Culture and Sports

Pikionis intervention (late 50s) and the unification of the archaeological sites of Athens (2000's)

Failure of earlier conservation interventions

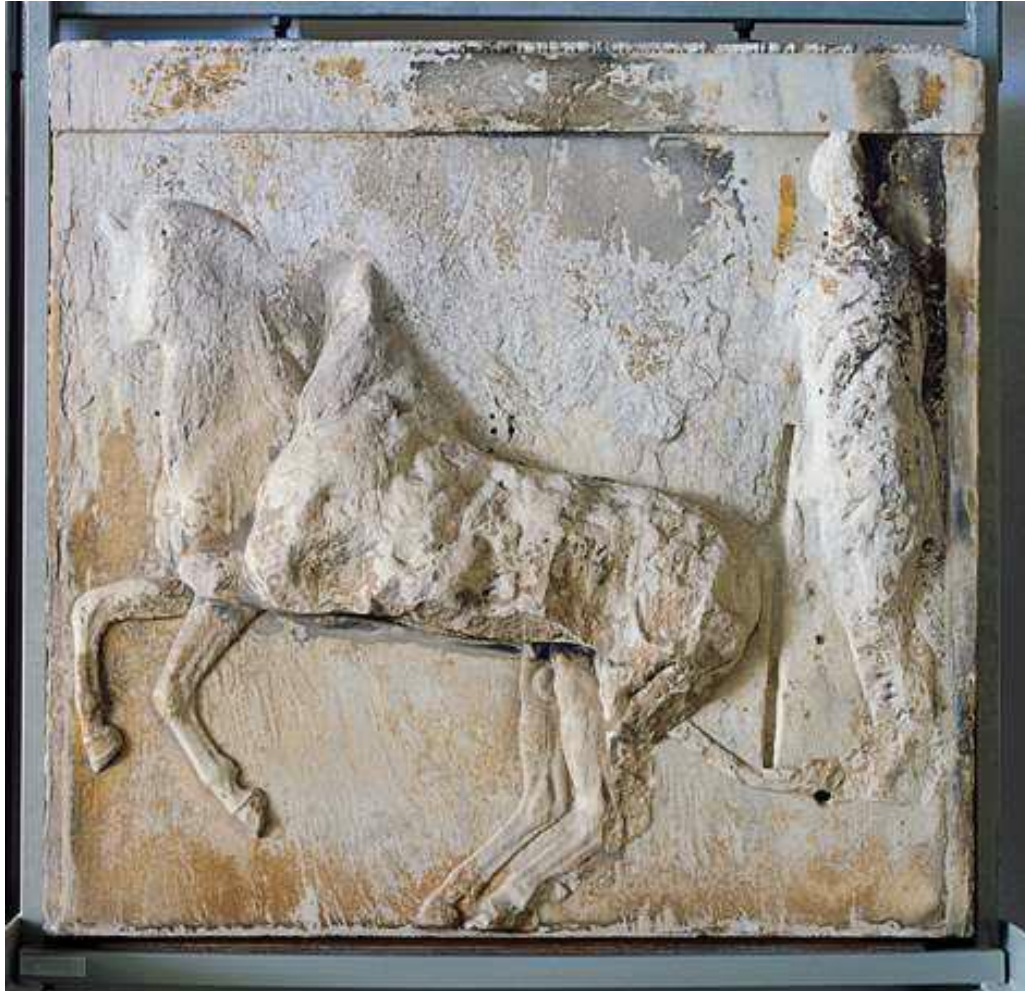
- The faces of human figures, depicted on the metopes of Parthenon, were systematically erased by the fanatic early Christians (here metope, nr. 10 from the east side of the Parthenon Temple)

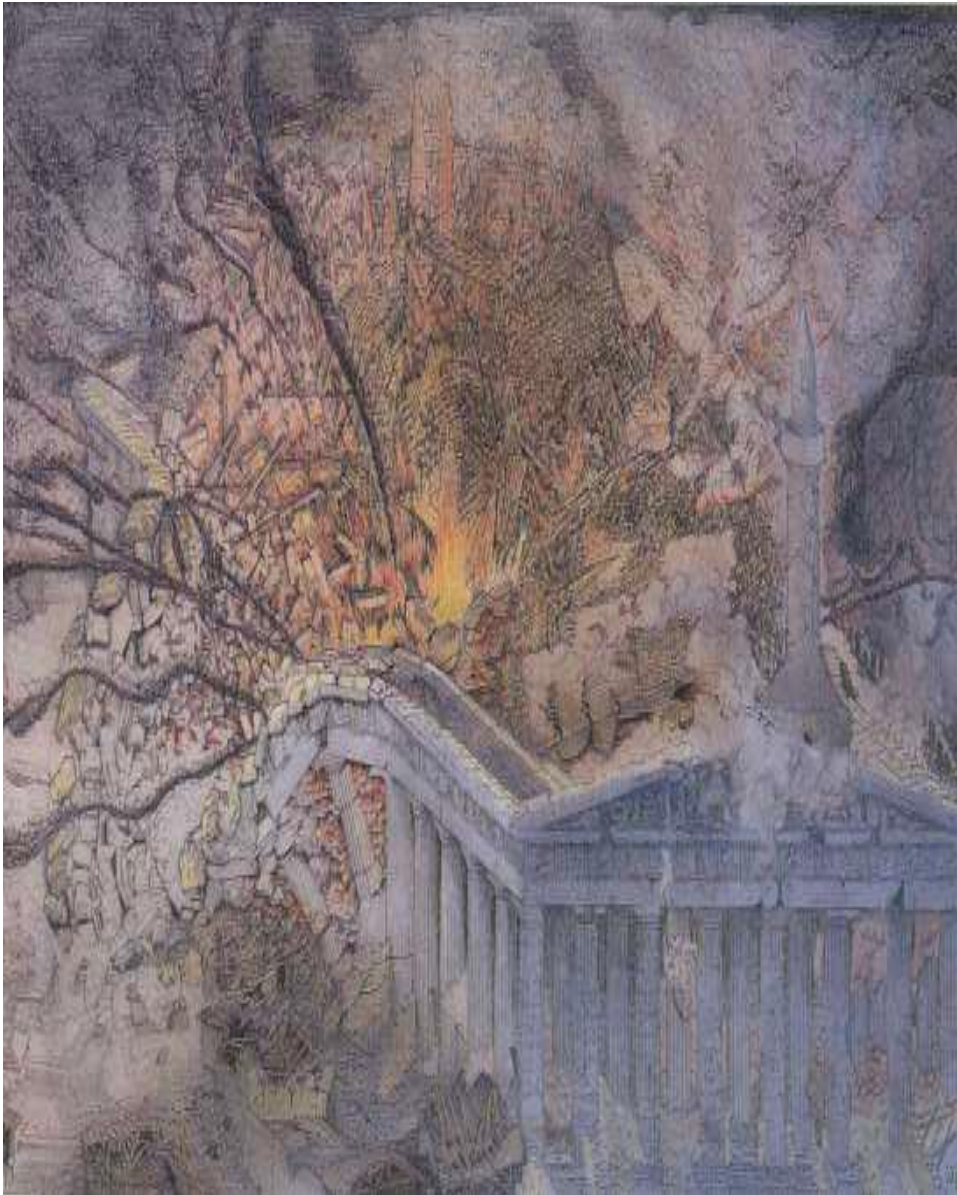
- **The destruction of Parthenon in 1687.**
- **In 1656, the Propylaia, were also exploded, after they were hit by thunderstorm.**

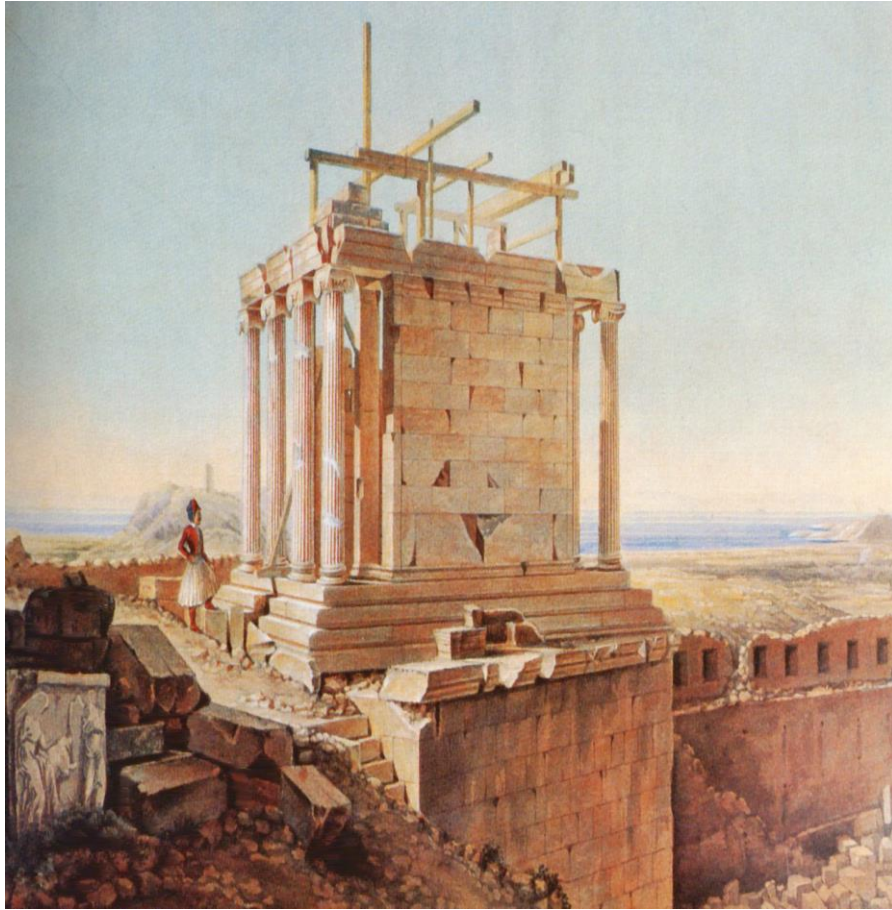
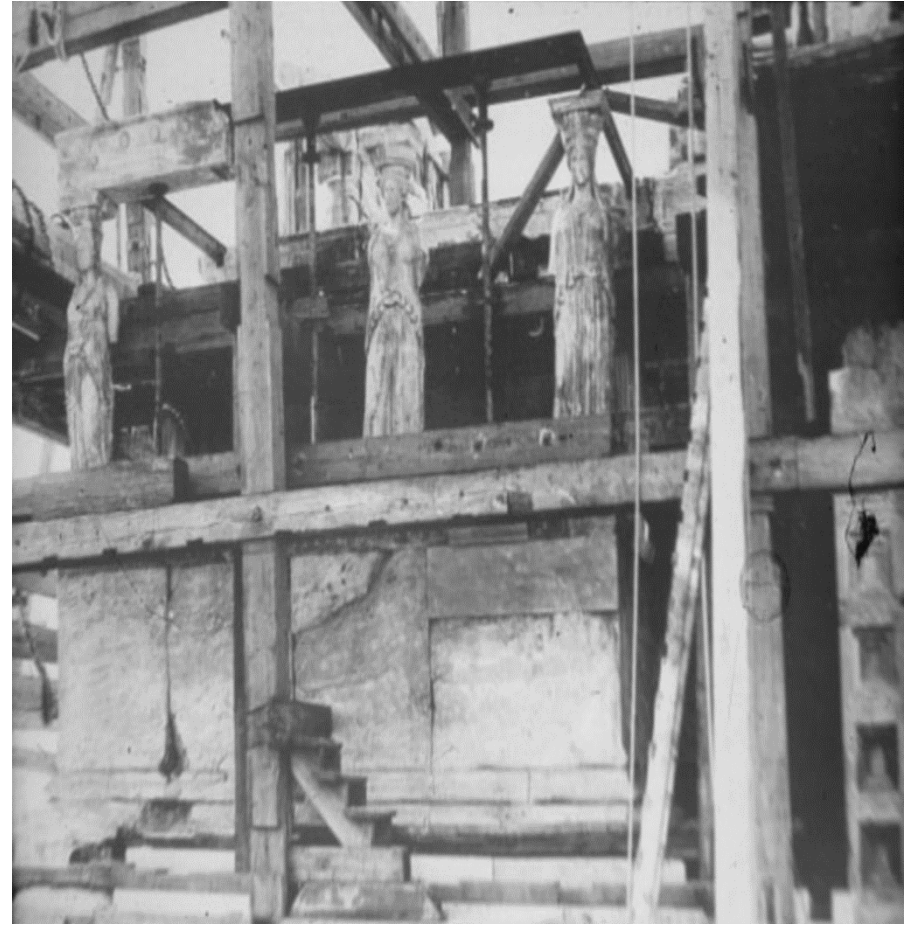
The type of failure appears in the form of fractures, cracks or in the form of delamination, which is the splintering - breaking off of large pieces from the surface of the marble. Most of the cracks have been caused by the rusting and swelling of the iron reinforcements, mainly from the Balanos restoration (1890-1937)

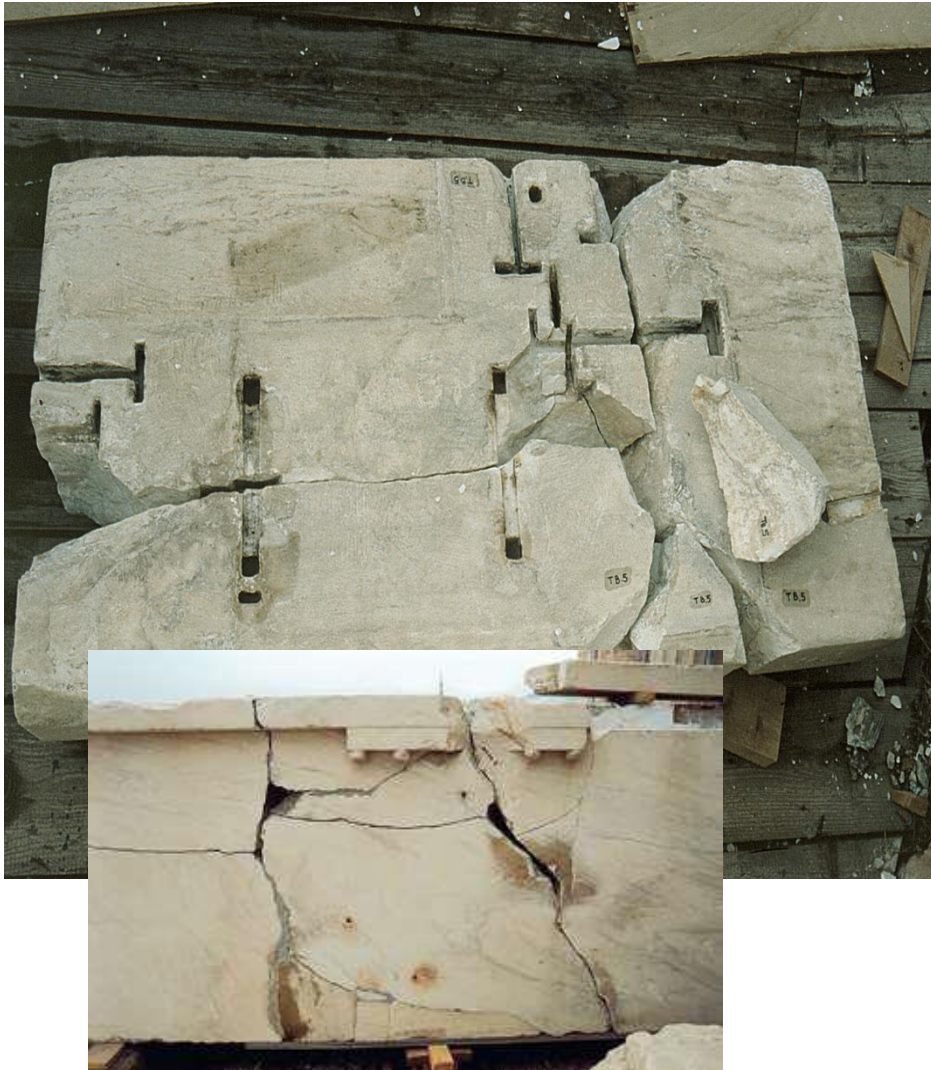
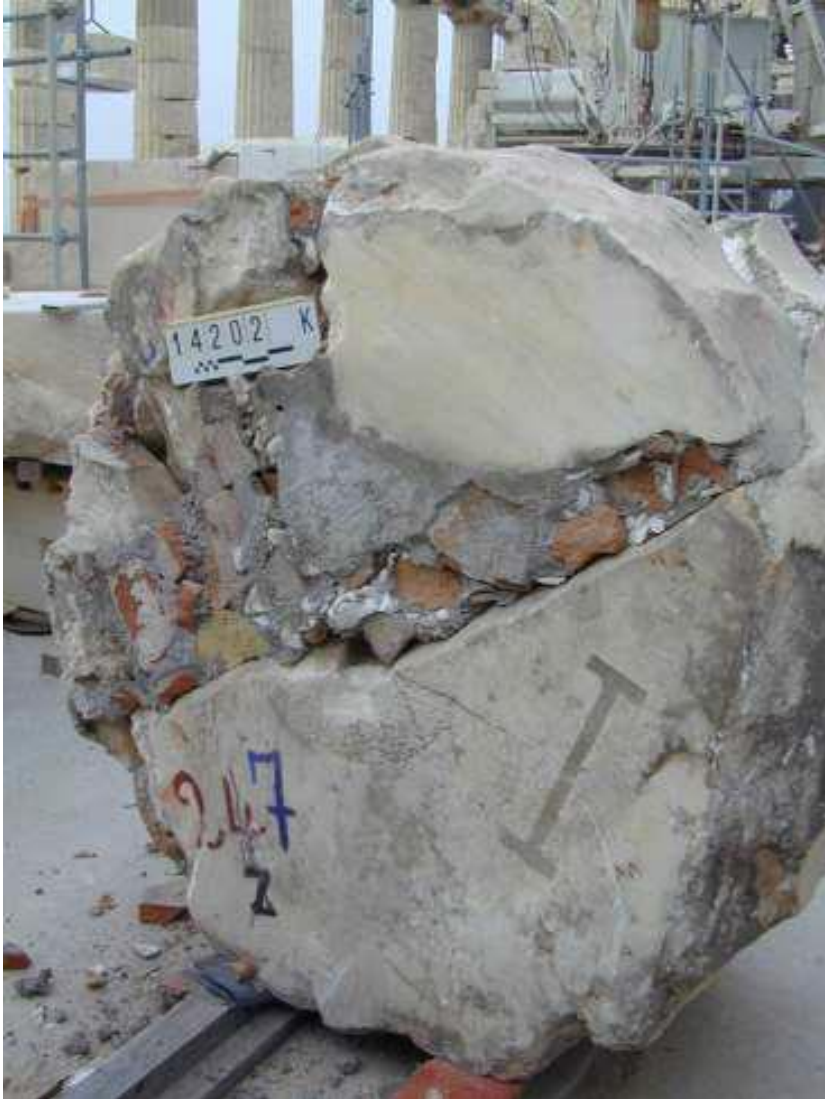
Failure of earlier conservation interventions

There are problems resulting from the mortars used in the past to join fragments and to point cracks. Most are constructed with Sorrel or Meyer cement, which was used extensively on monuments for more than 80 years. It is a white plaster with two basic components, magnesium oxide and magnesium chloride. Today, most of the mortars of this type are flaking or powdering, producing soluble salts and the adjoining marble crumbles

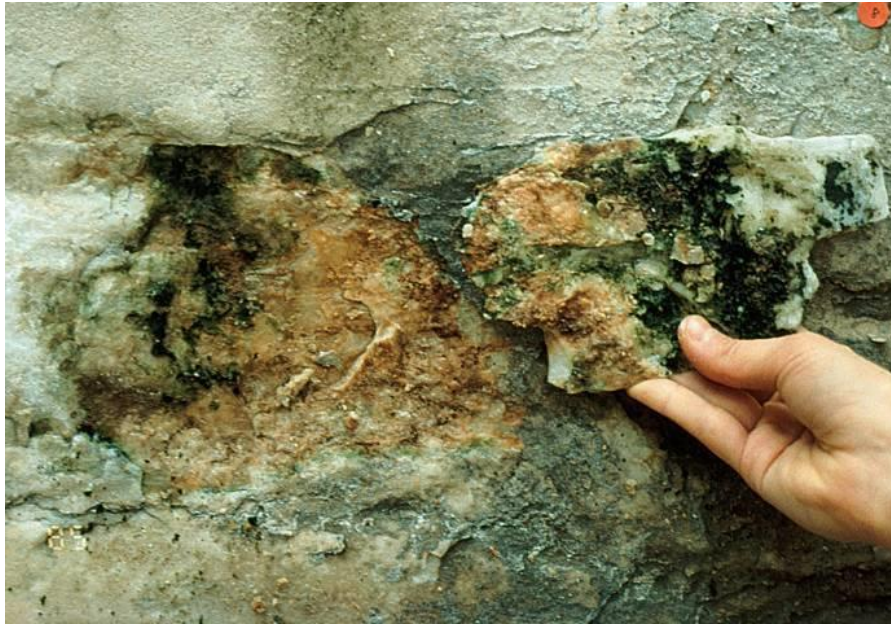
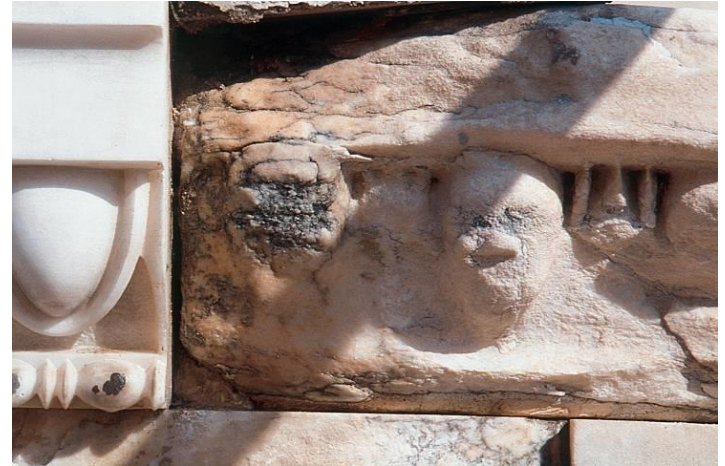
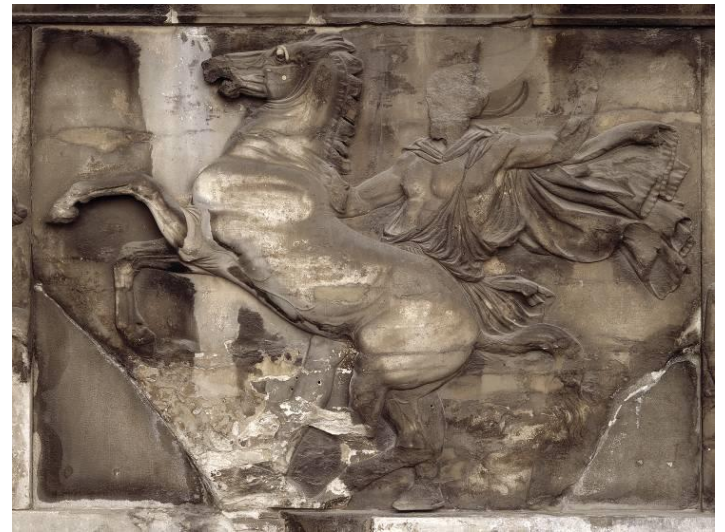
Surface erosion of the marble from

- the atmospheric pollution and
- biological reasons

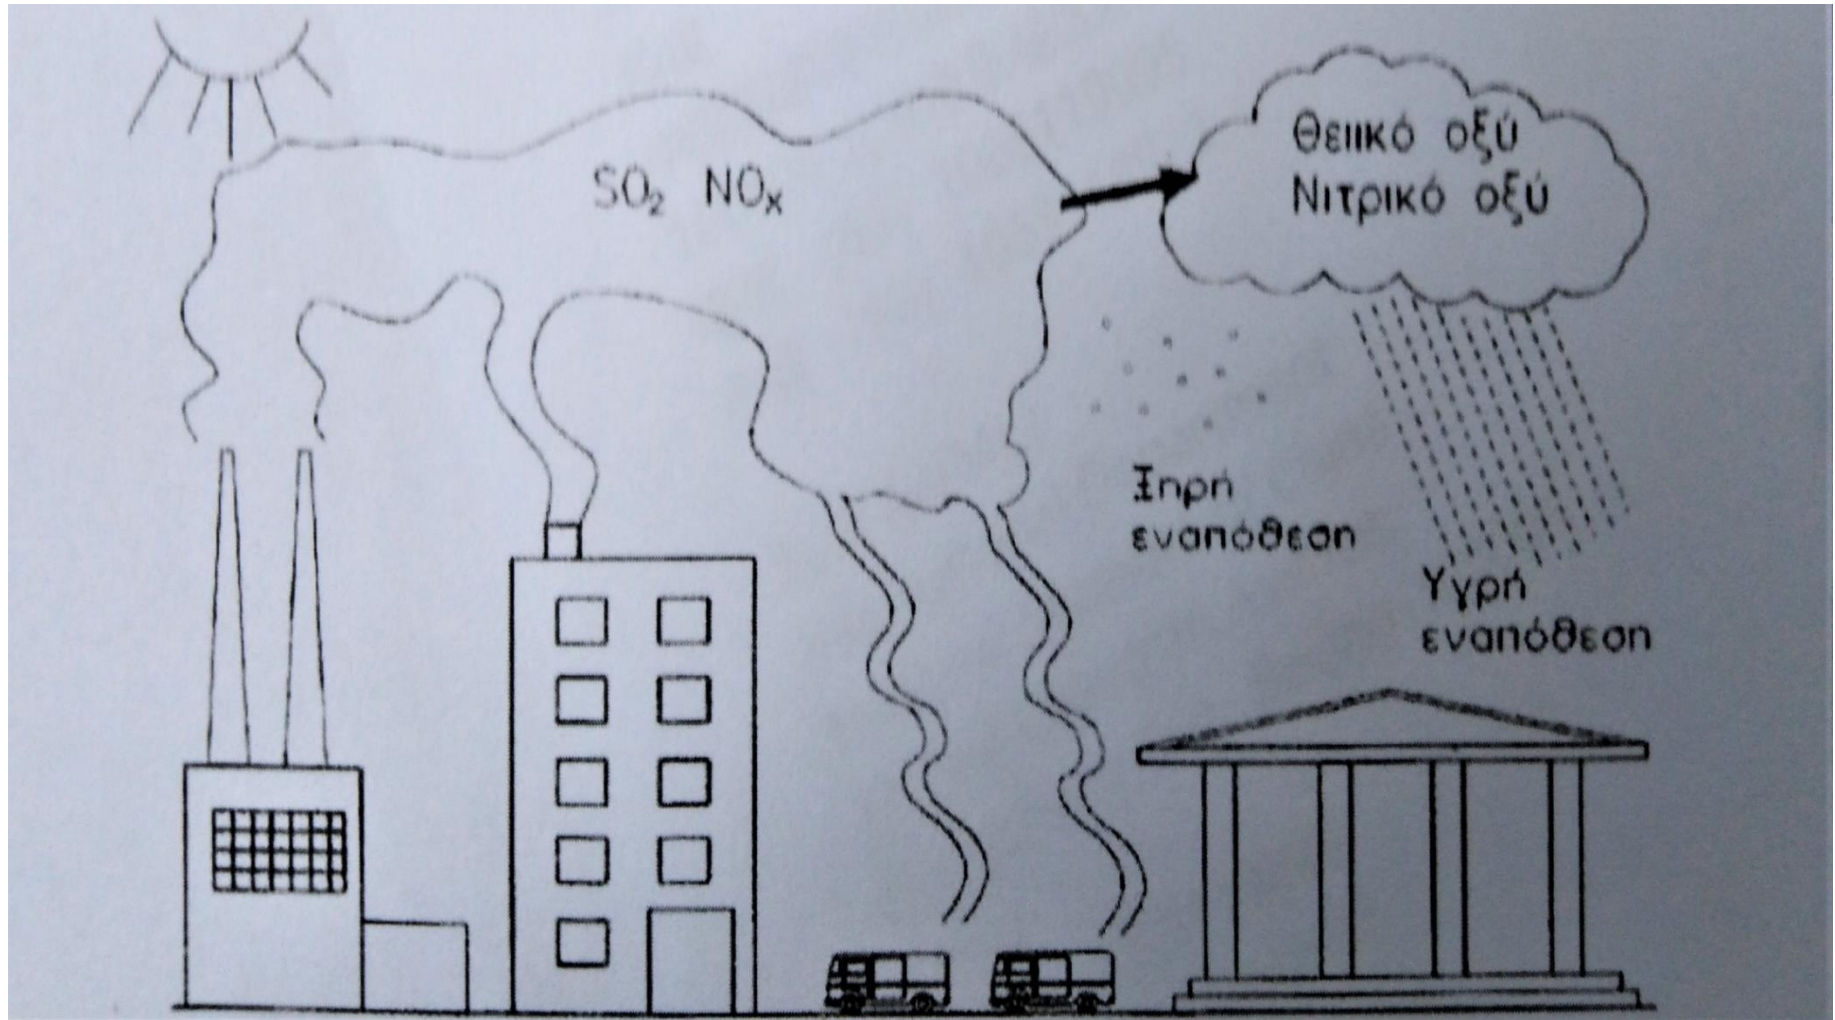
DETACHMENT

Appears on surface areas directly exposed to rain fall. The rainwater acidified by carbon dioxide, sulphur dioxide and nitrogen oxides from the air pollution slowly dissolves the marble. This damage is evident in the effect on the marble crystals, leading to the loss of their cohesion and ultimately in their falling off

- **Disintegration:**
Detachment
of single grains
or aggregates of grains.

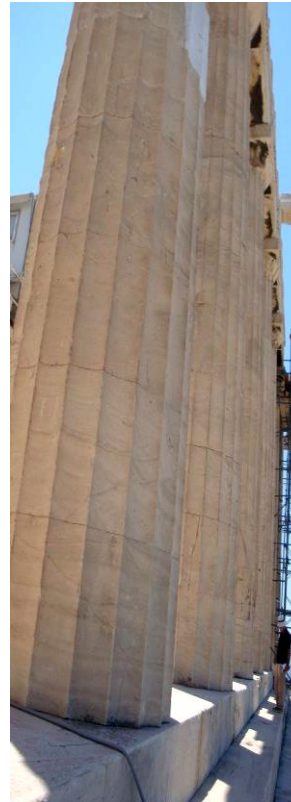
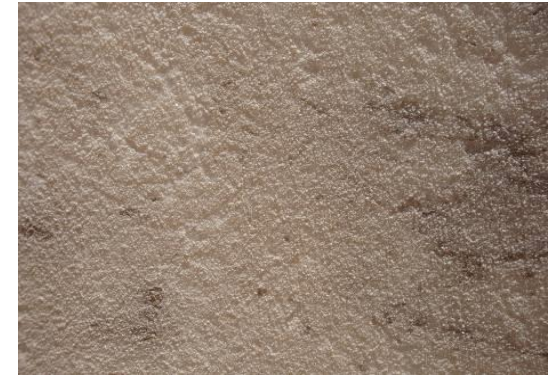
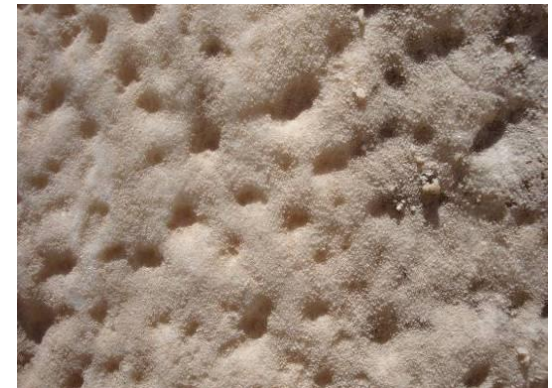
**Parthenon,
North Colonnade**

Granular disintegration

Sugaring:
due mainly
to thermal stresses
and the atmospheric
action

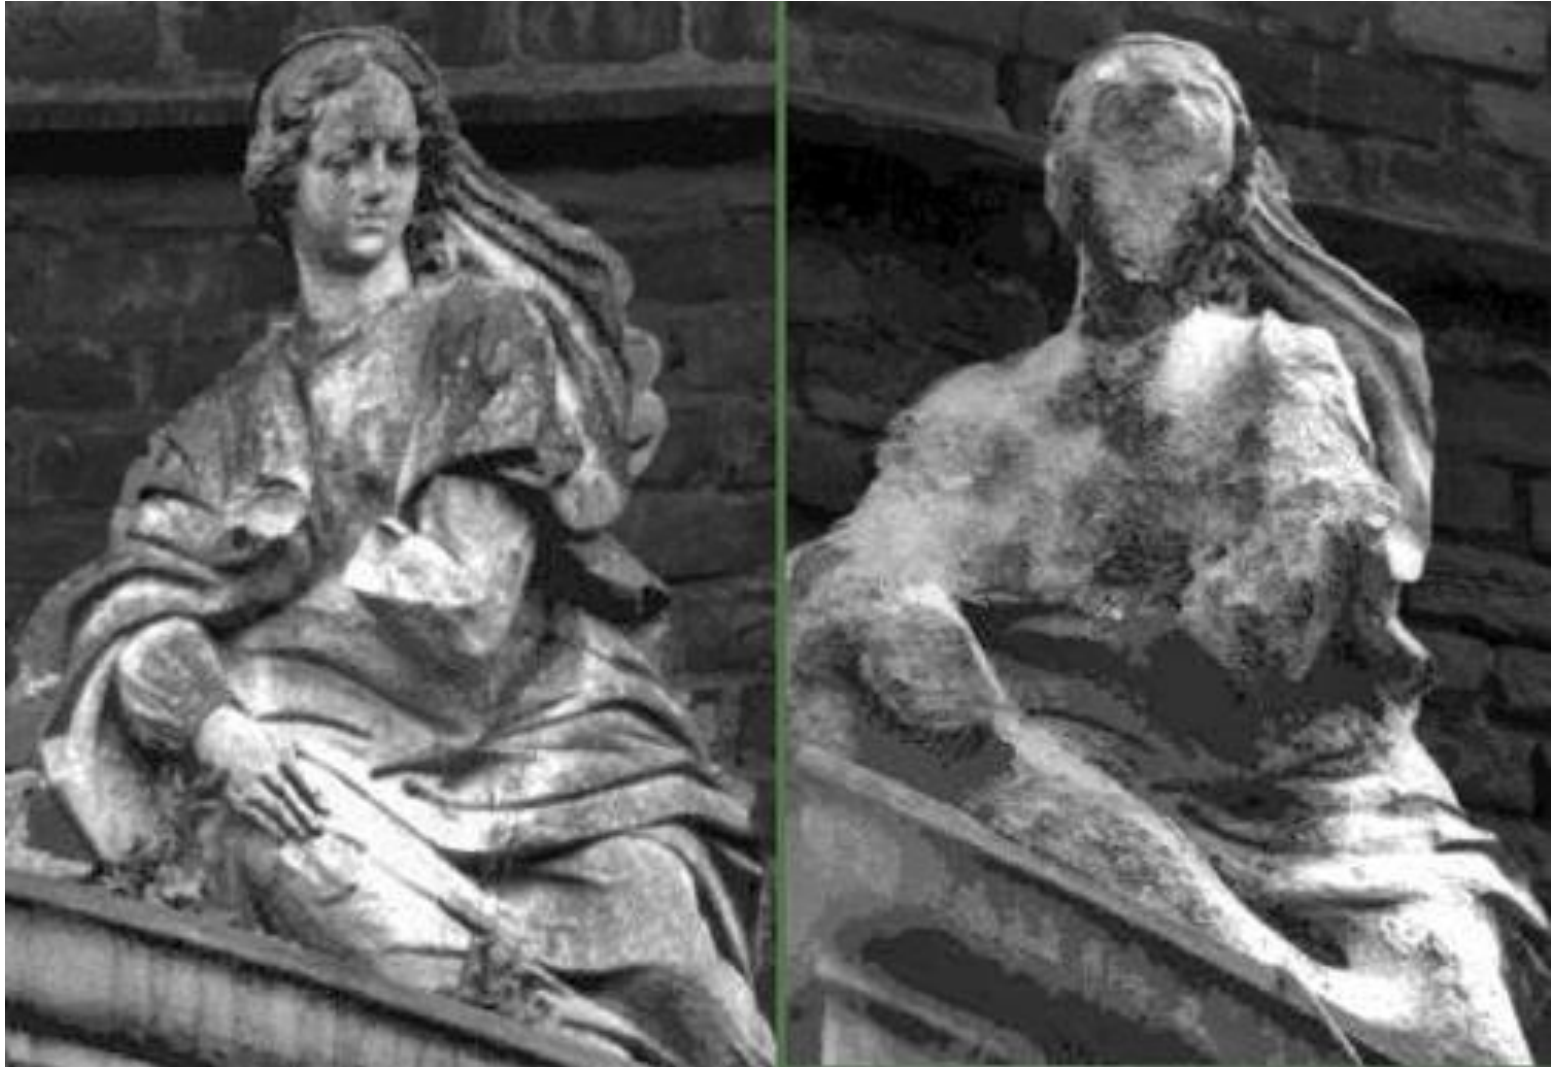
DISCOLORATION & DEPOSIT

Crust: Generally coherent accumulation of materials on the surface.

Black Crust: Kind of crust developing generally on areas protected against direct rainfall or water runoff in urban environment. They are usually adhere firmly to the substrate and composed mainly of particles from the atmosphere, trapped into a gypsum ($\text{CaSO}_4 \cdot 2\text{H}_2\text{O}$) matrix.

Black Crusts of Parthenon

- >200 μm thick
- Gypsum, Calcite
- Si, Al, Fe, Pb, Ti, Zn, Mn
(from atmospheric pollutants)

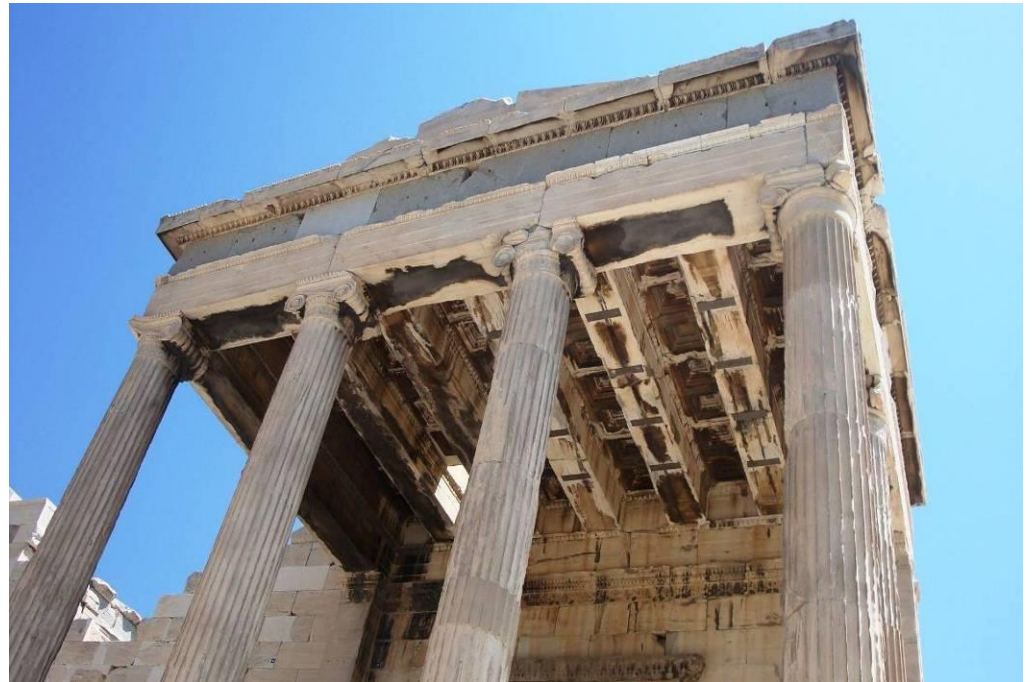
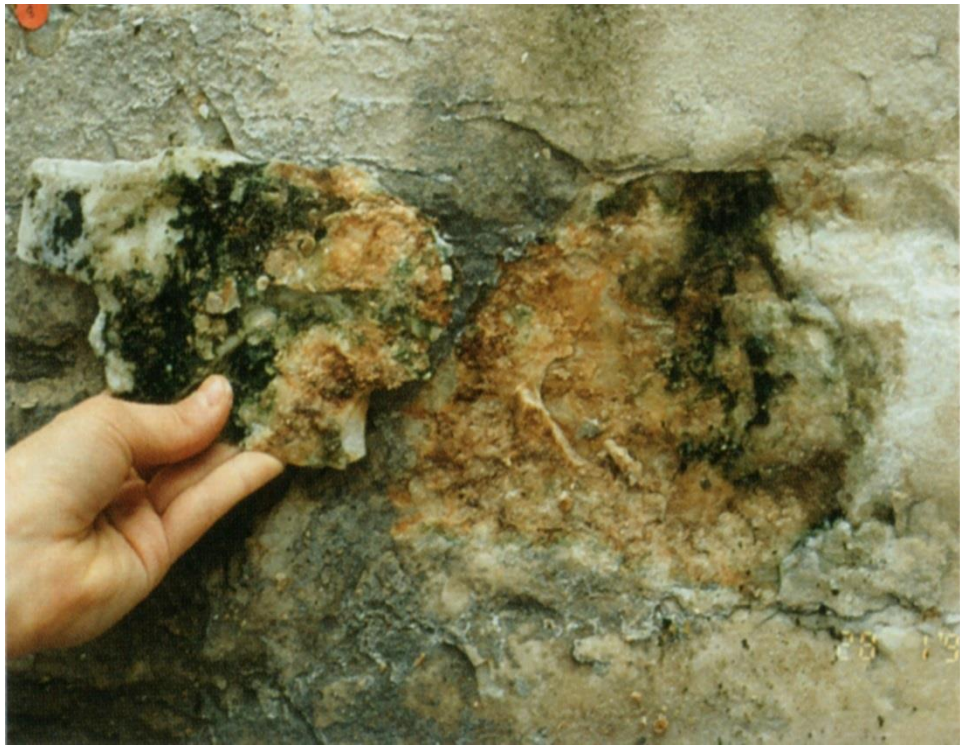
Biodeterioration factors

Research by microbiologists has revealed the presence of a variety of microbial colonies, consisted of bacteria, algae, fungi and lichens. The biological factor in the physico-chemical damage to the marble has been shown to be significant. Both epilithic and hasmolithic microflora alter the colour of the monuments' surface, the secretion of erosive compounds from various micro-organisms causes the dissolution of the calcium carbonate and a large part of the microflora exerts micro-pressures resulting in surface decay.

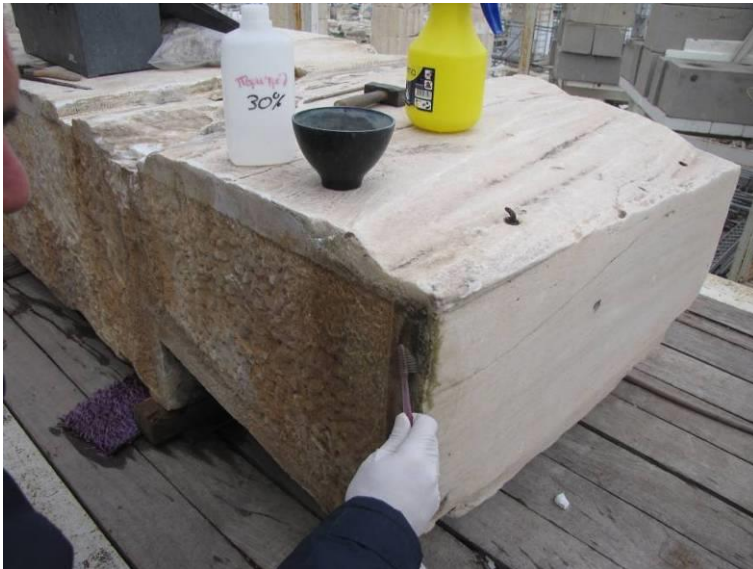
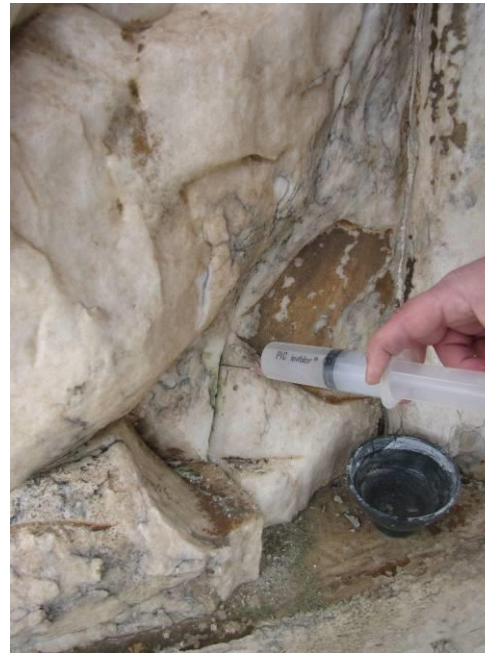
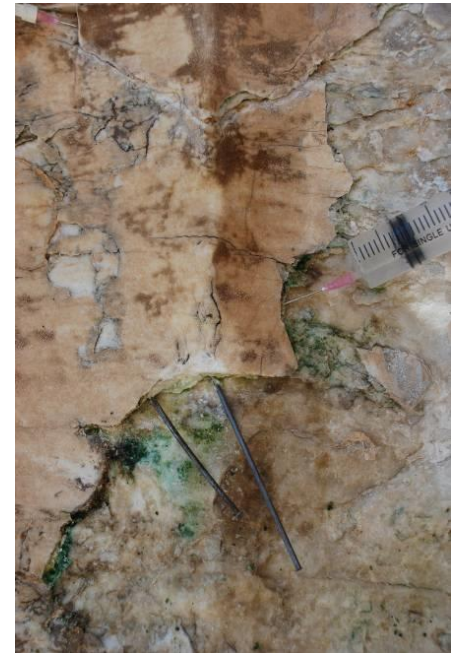
- **Biological Colonization**, especially the microbes that acts behind the surface of the stone and inside the cracks, gaps, etc.
- By using **Hydrogen Peroxide (H_2O_2) (5-7%)**.

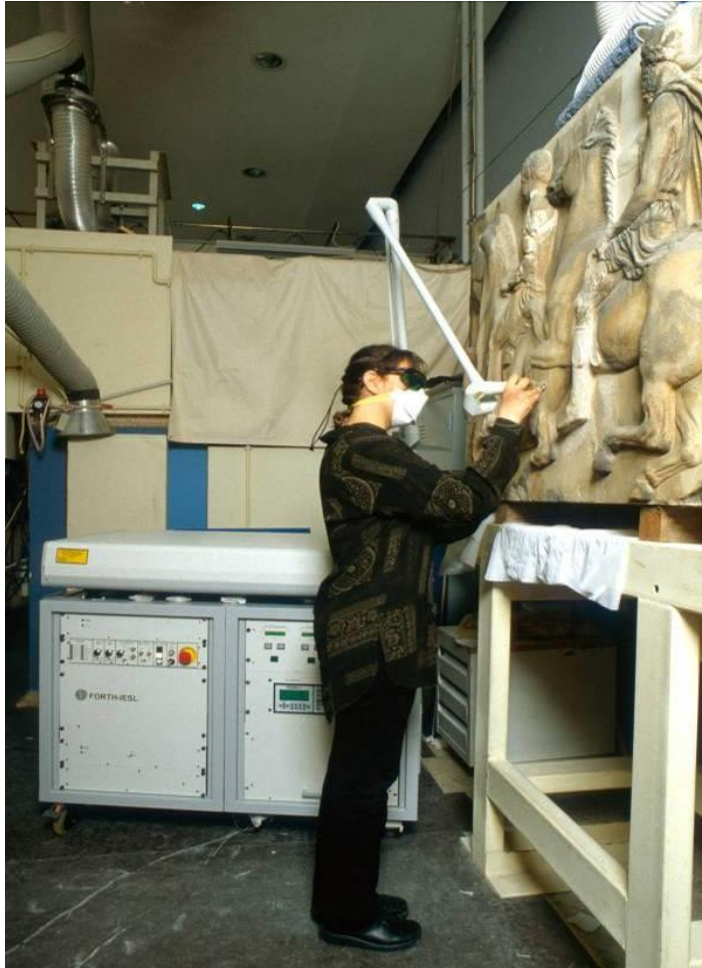
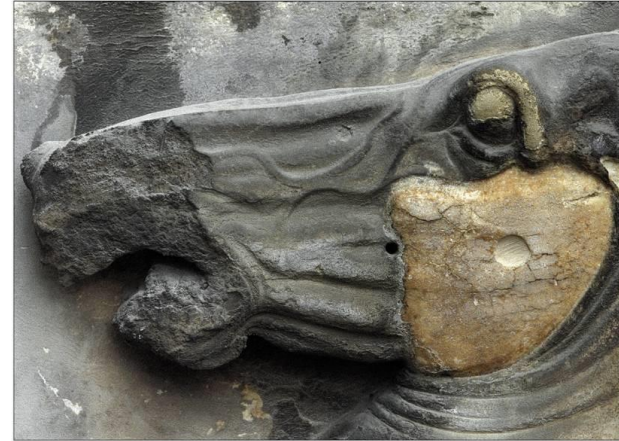
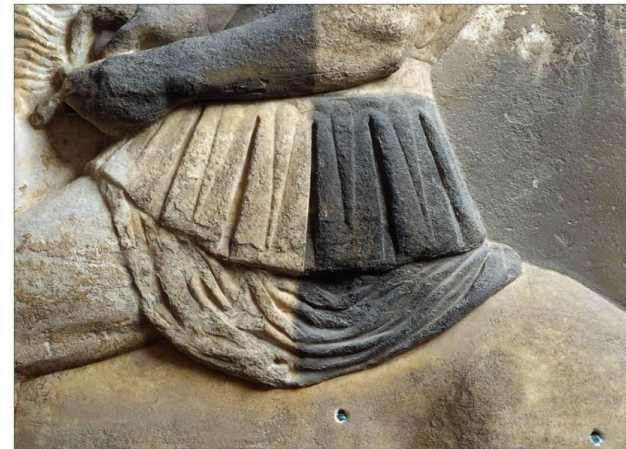
Monuments' Structure

- Worked stones without mortars
- Metal joining elements

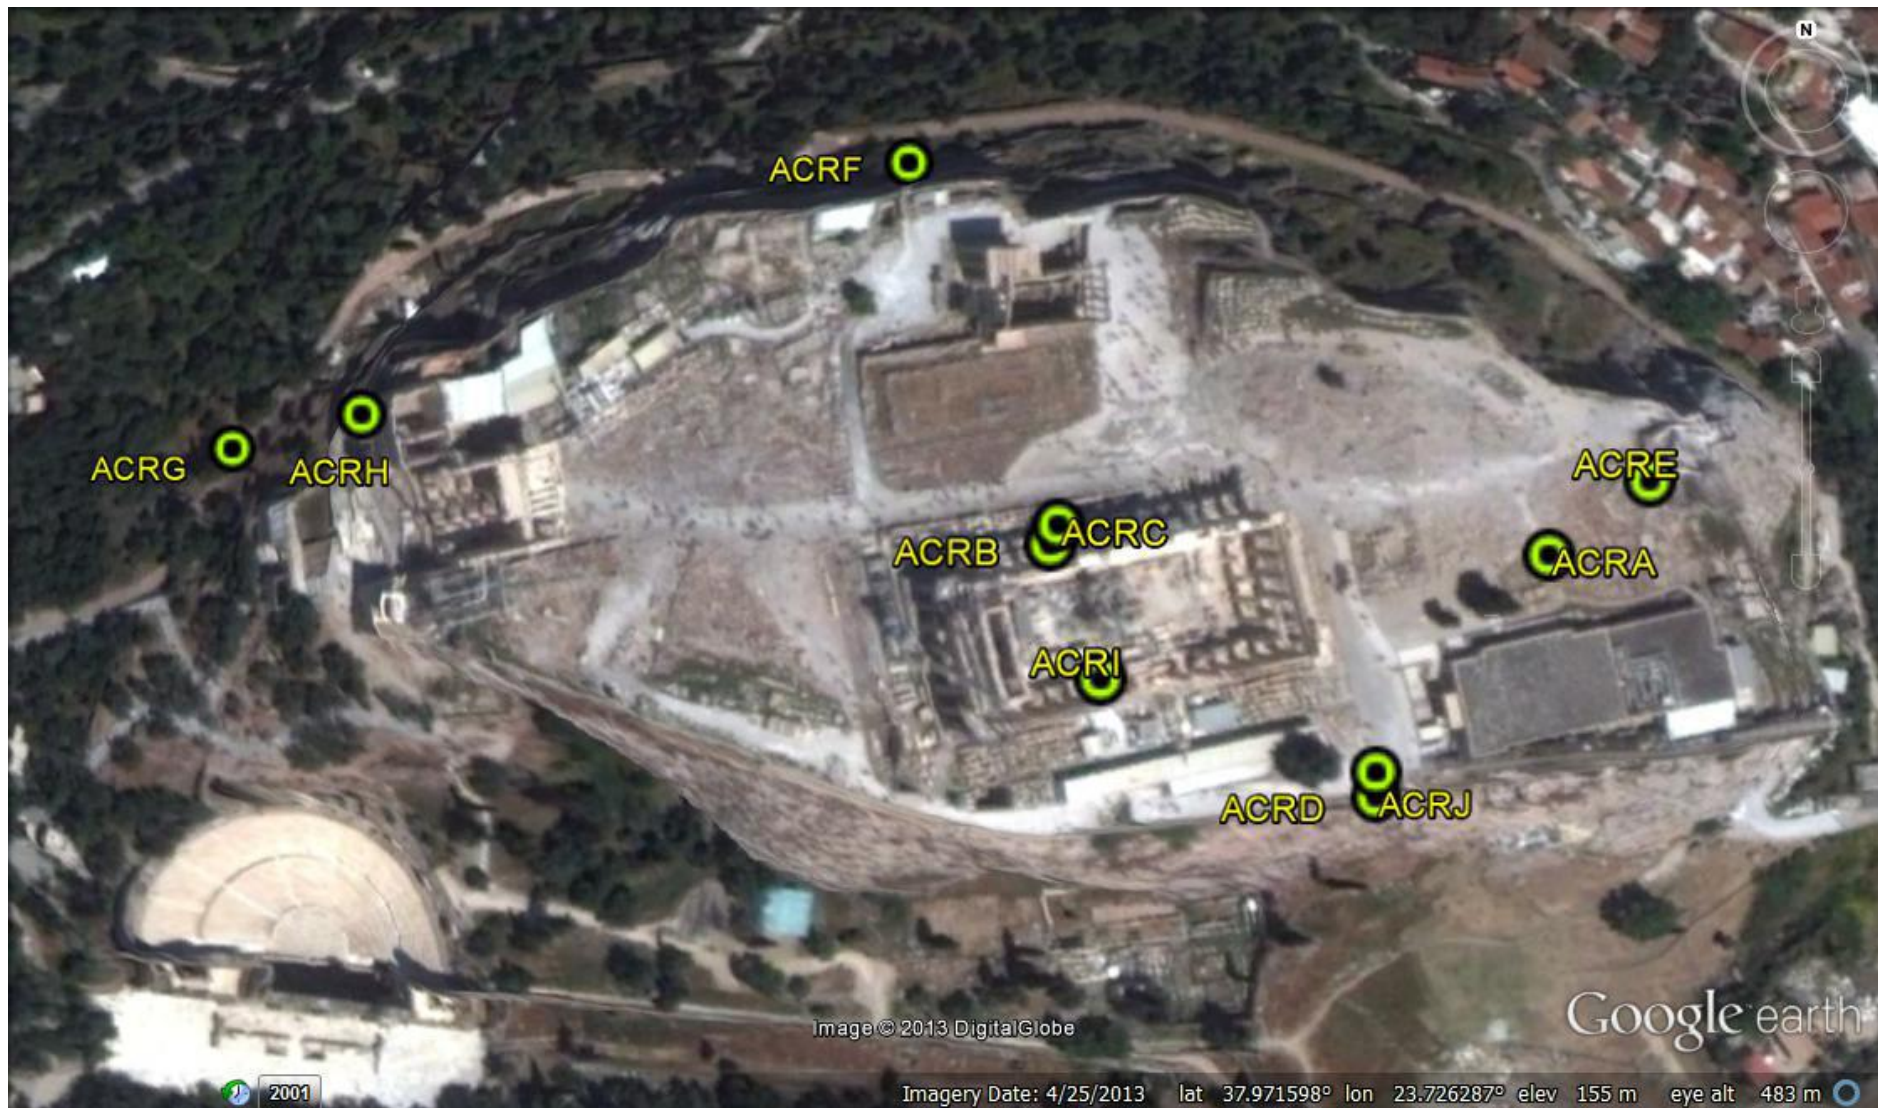
Location of the accelerometers on the Acropolis

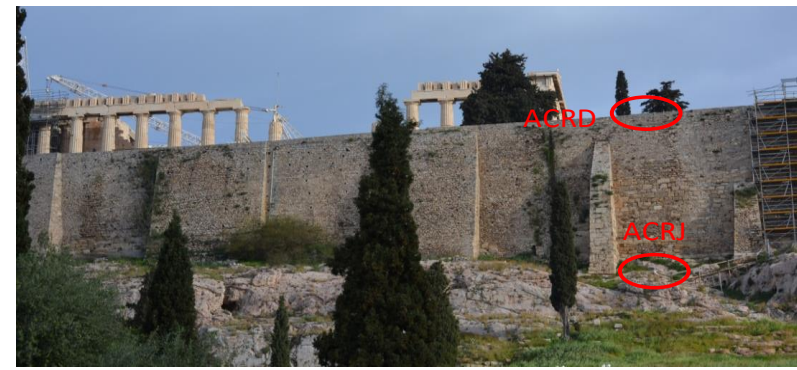
Monitoring with the combined use of accelerometers and fiber optic sensors

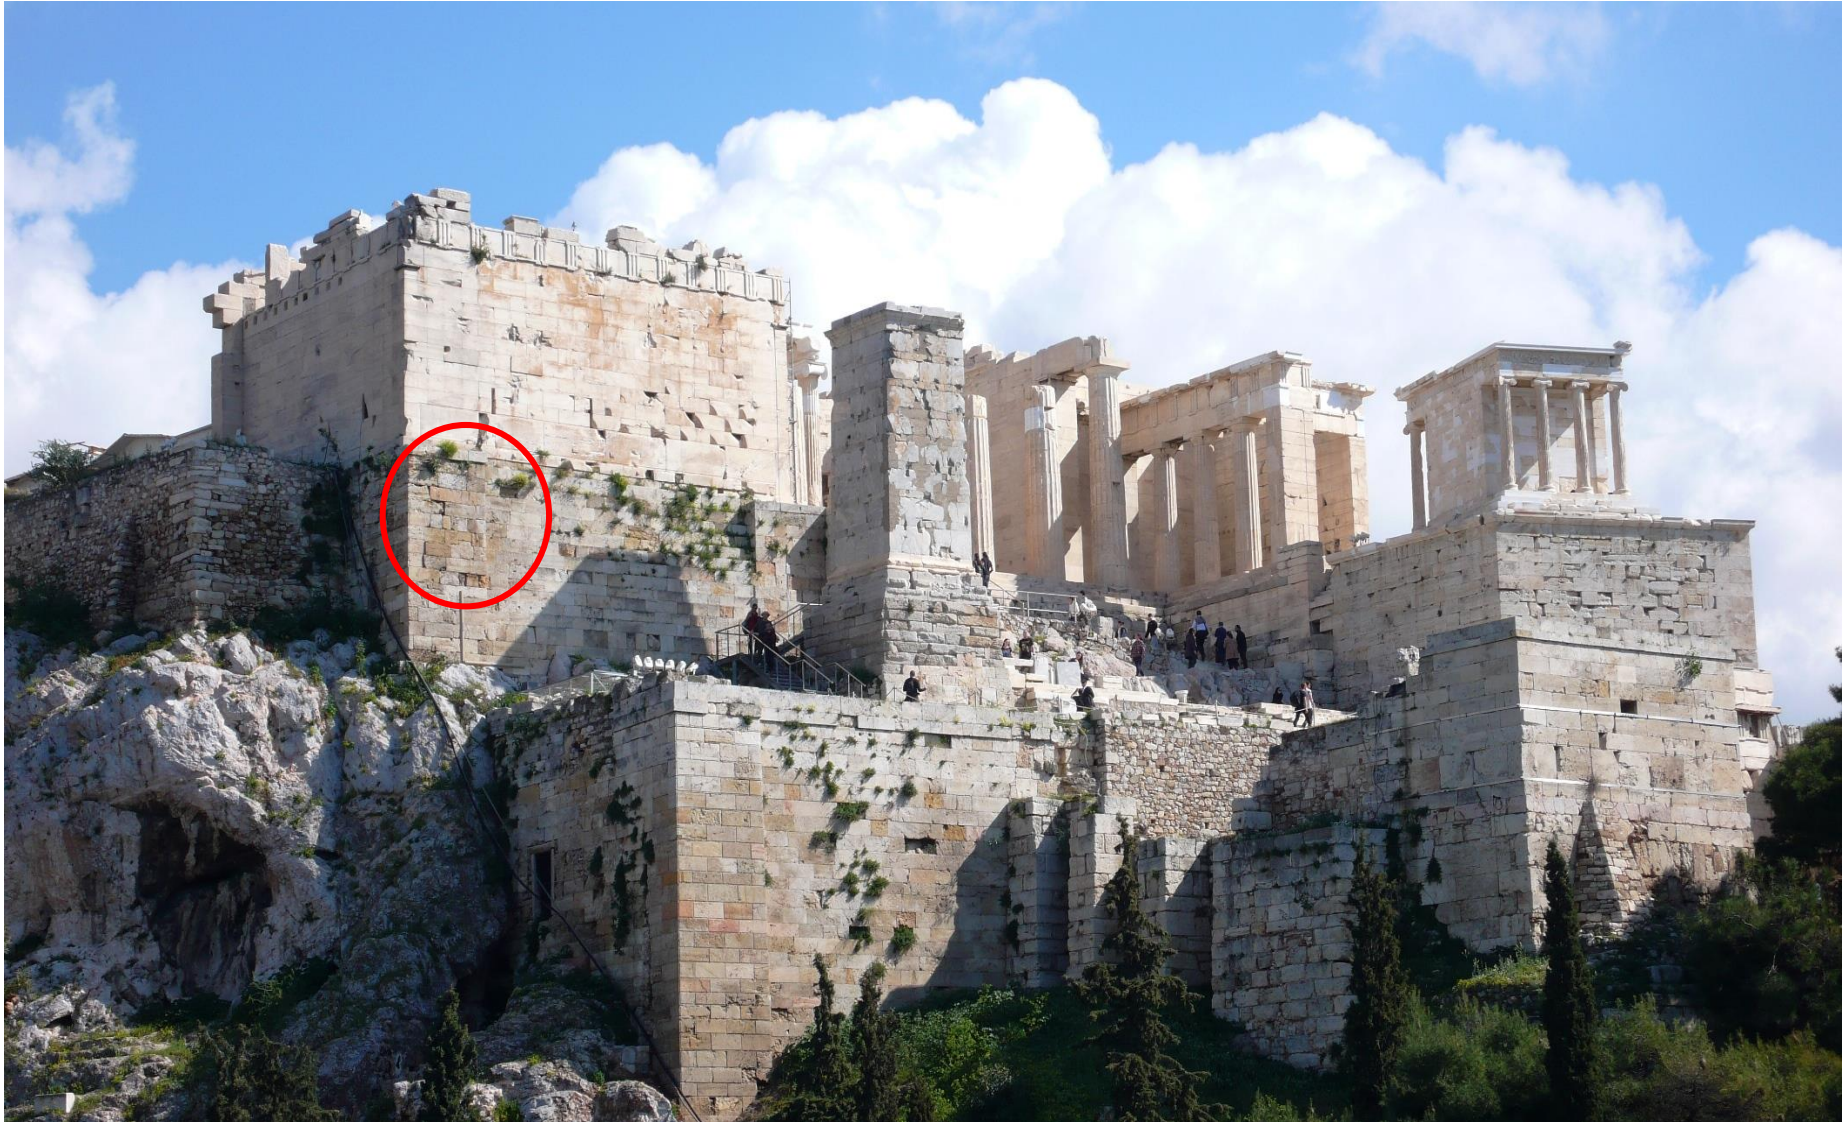
Monitoring with the use of micro fiber sensor at the base of the so called Pinakothiki (Gallery) of Propylaia.

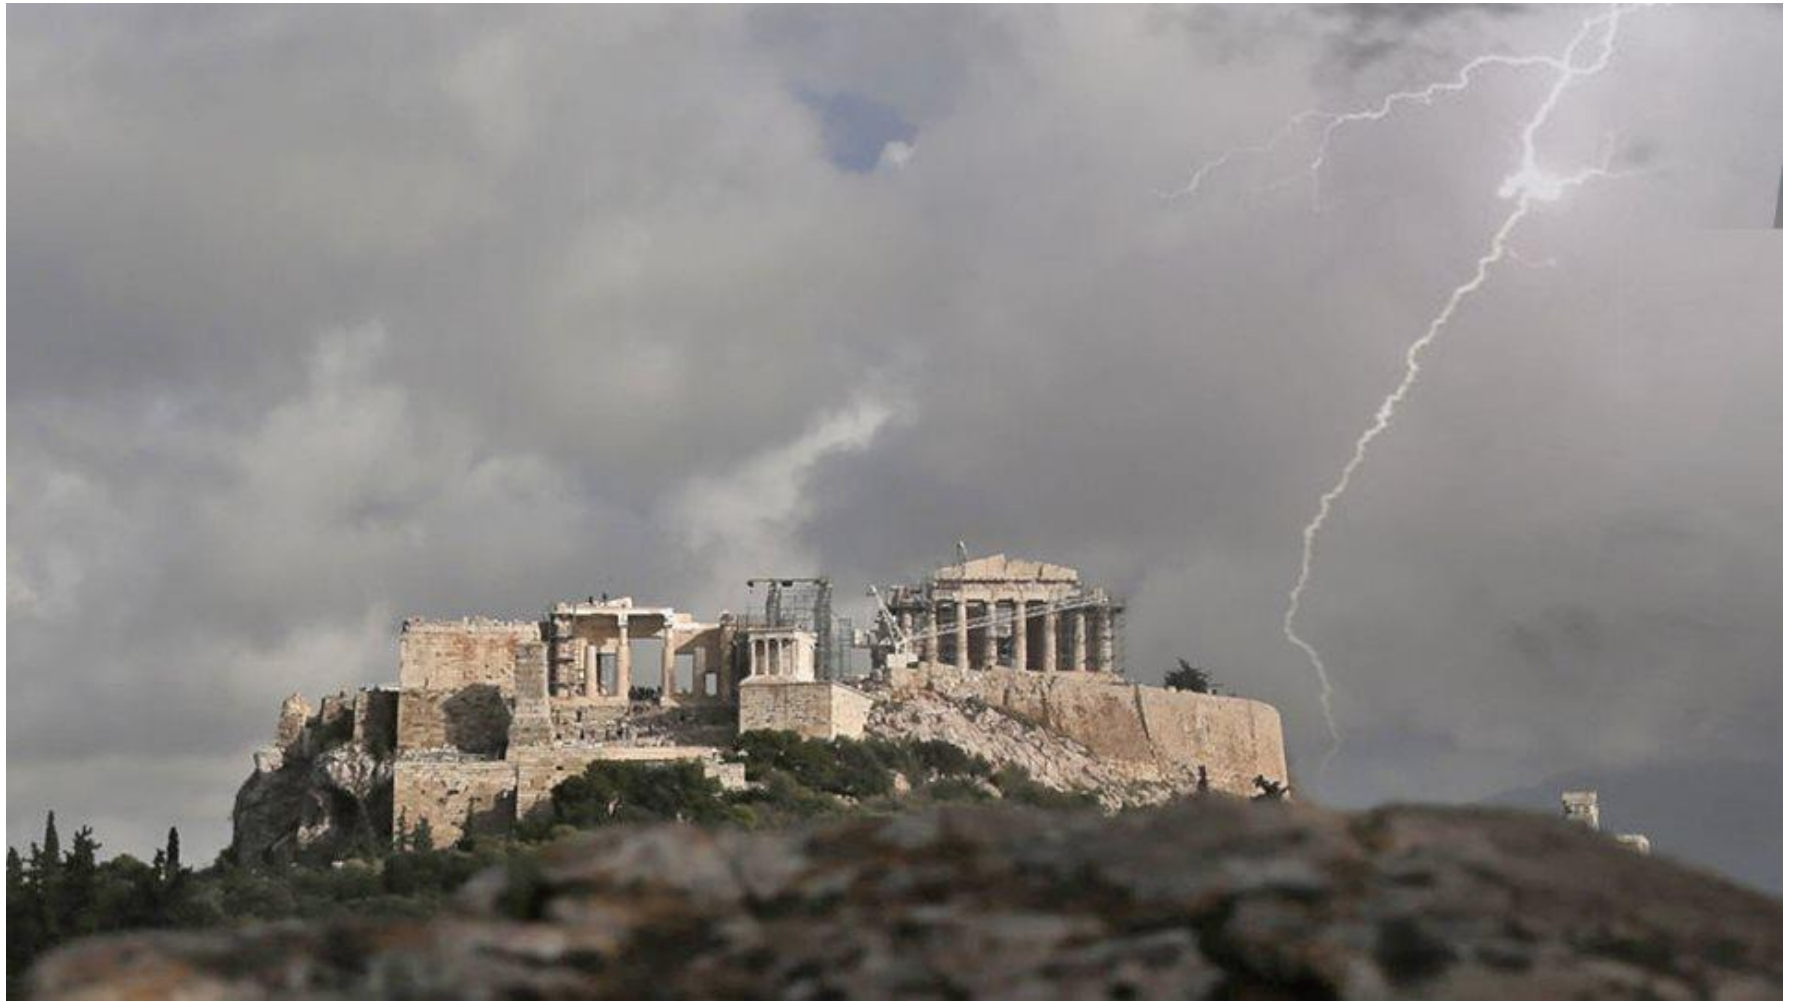
Unstable schistolithic rocks (southwestern slope)
