Dr. Maria Andreadaki – Vlazaki
Secretary General
Ministry of Culture and Sports

Pikionis intervention (late 50s) and the unification of the archaeological sites of Athens (2000's)

Failure of earlier conservation interventions

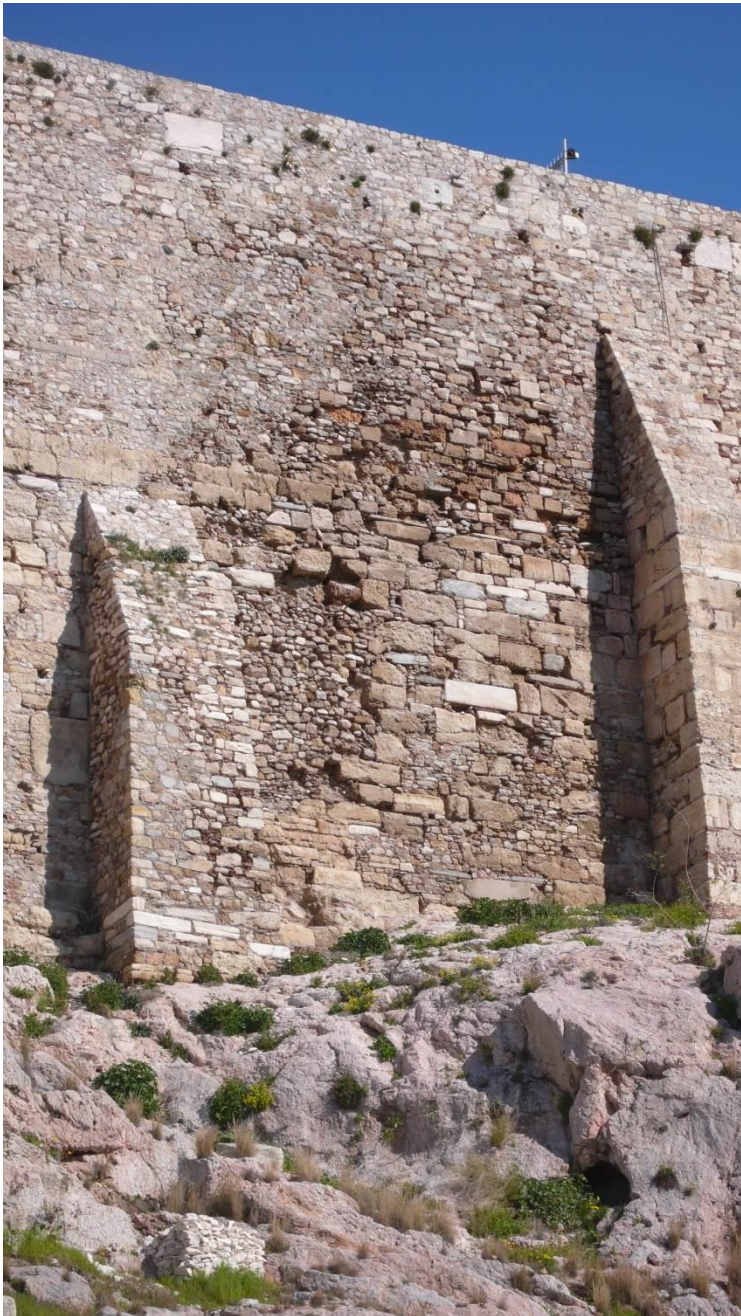
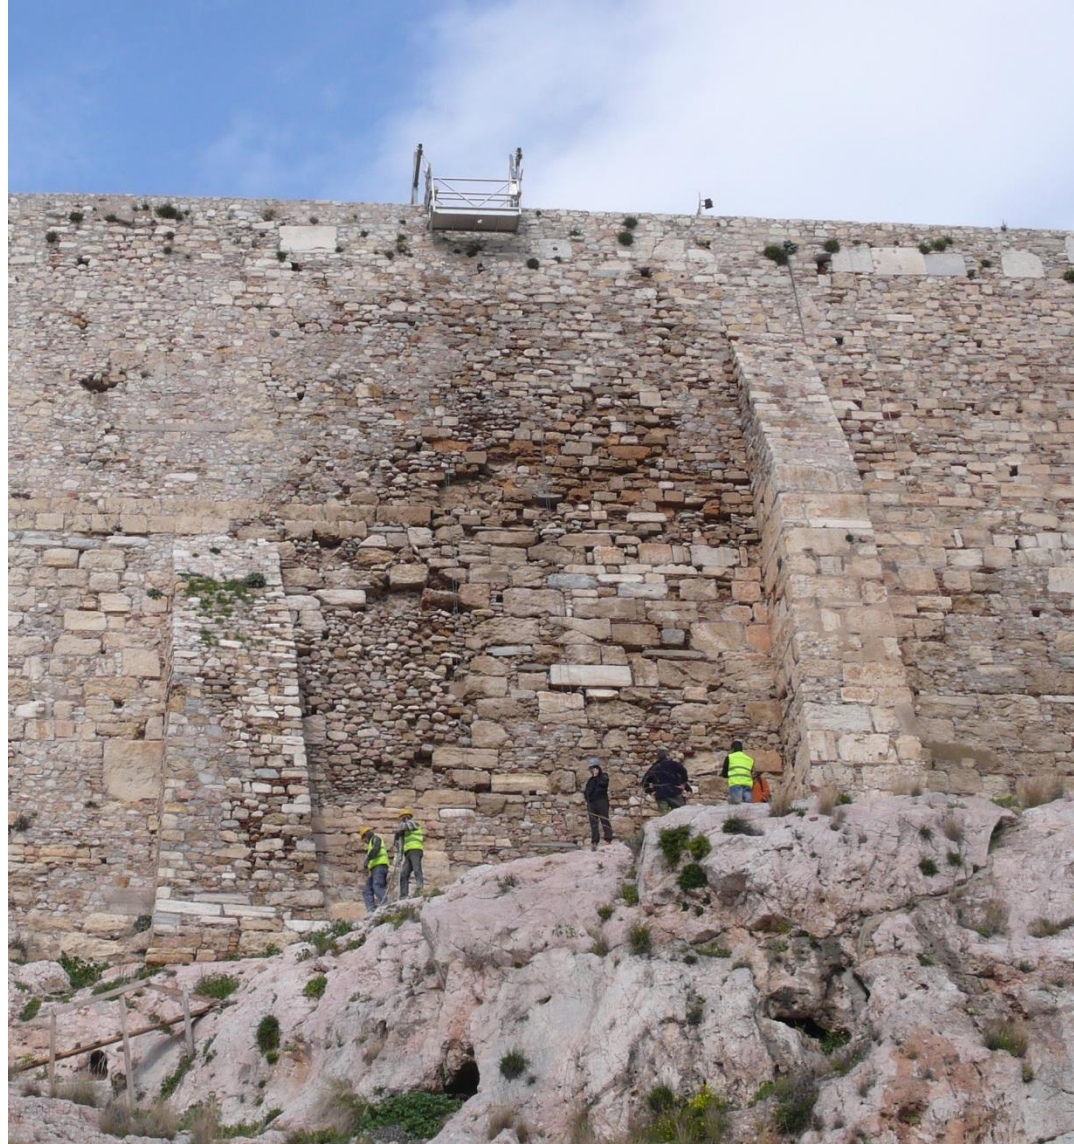
South Wall, area among 6th and 7th retaining wall

Study for the restoration of the south fortification wall of the Acropolis in the area between the 6th-7th retaining wall

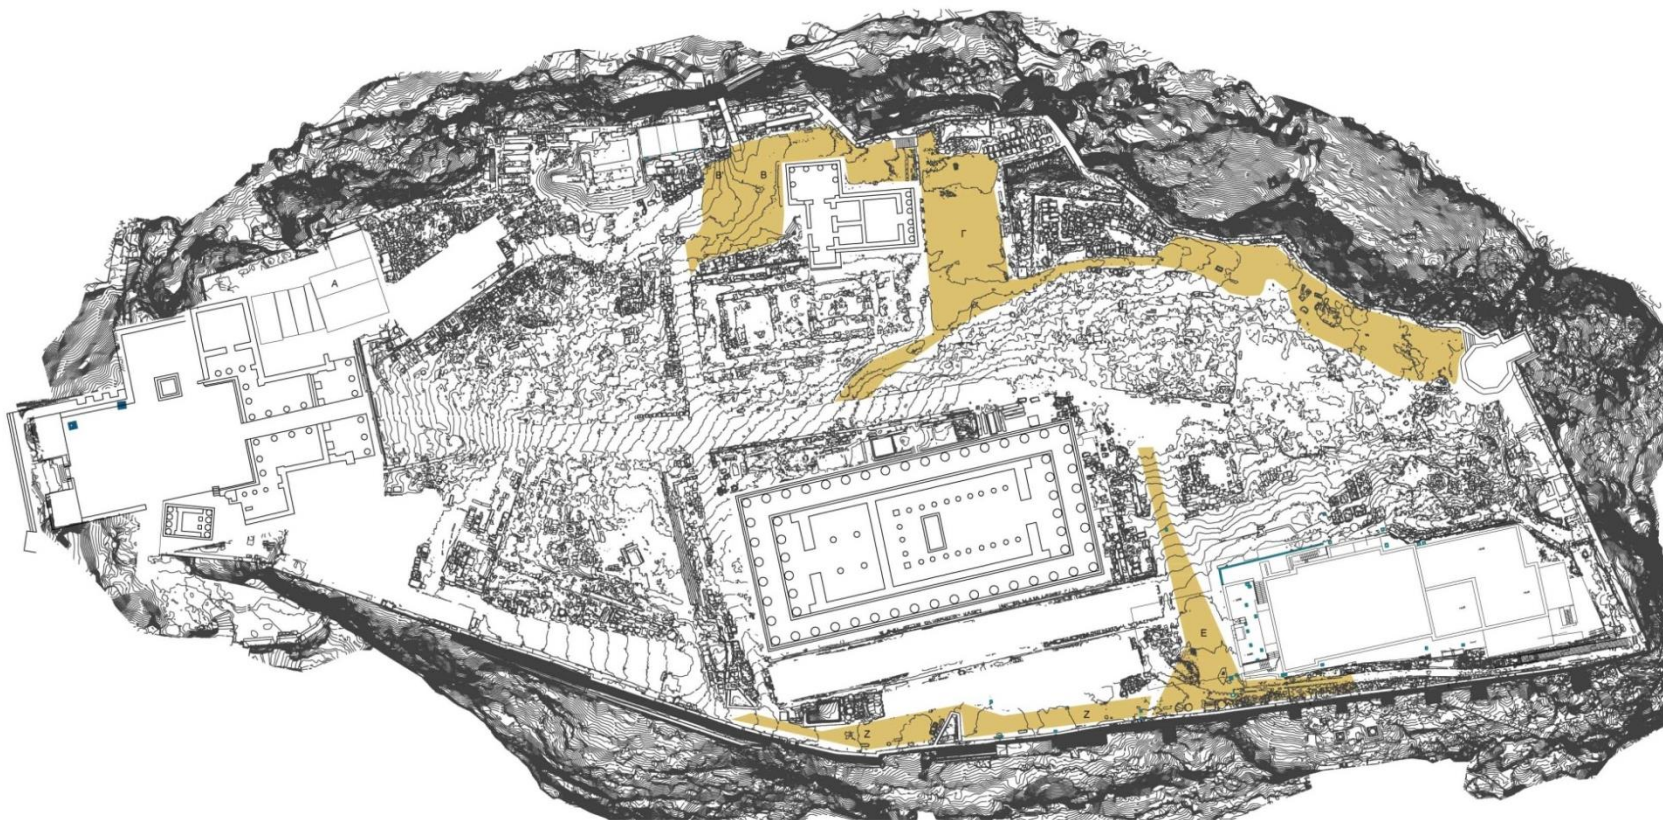
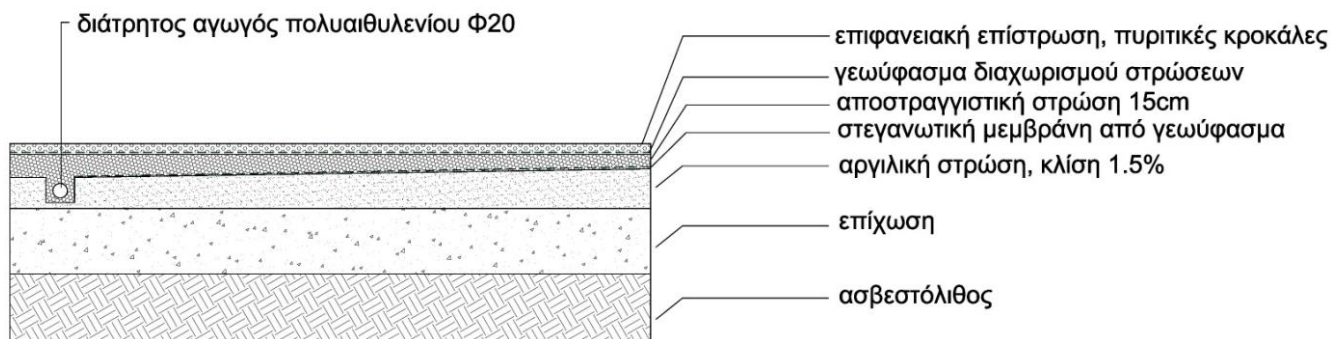
Preliminary study on the treatment of rainwater

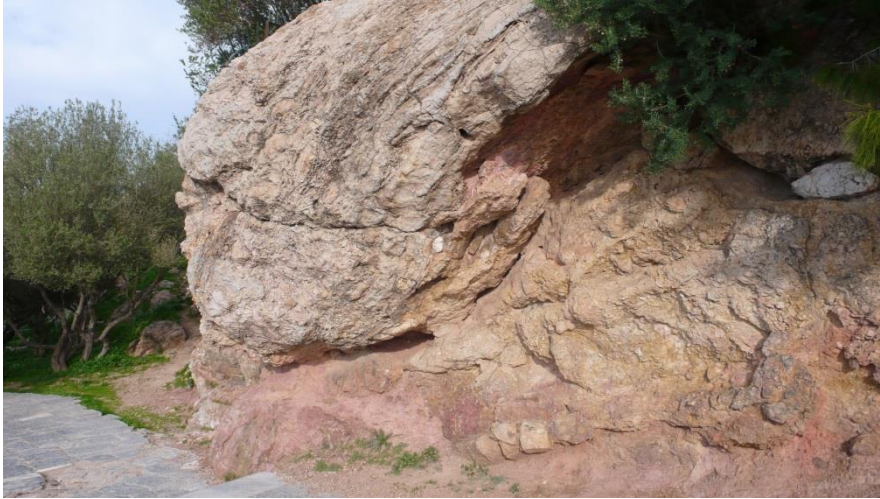
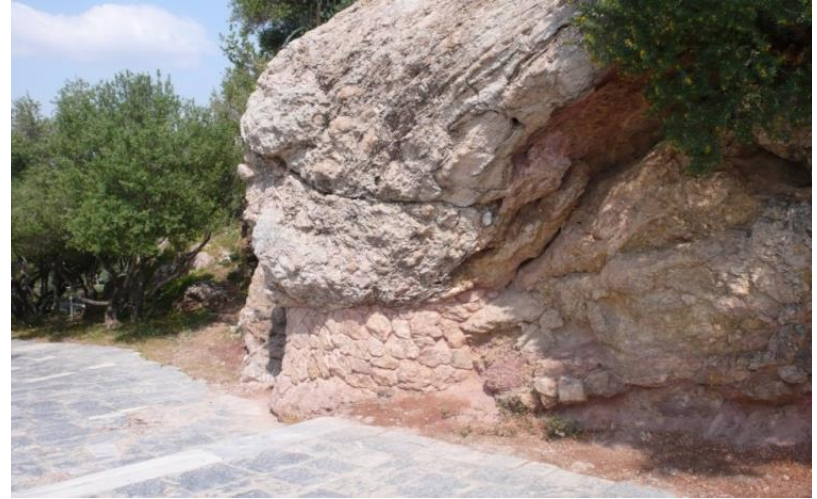
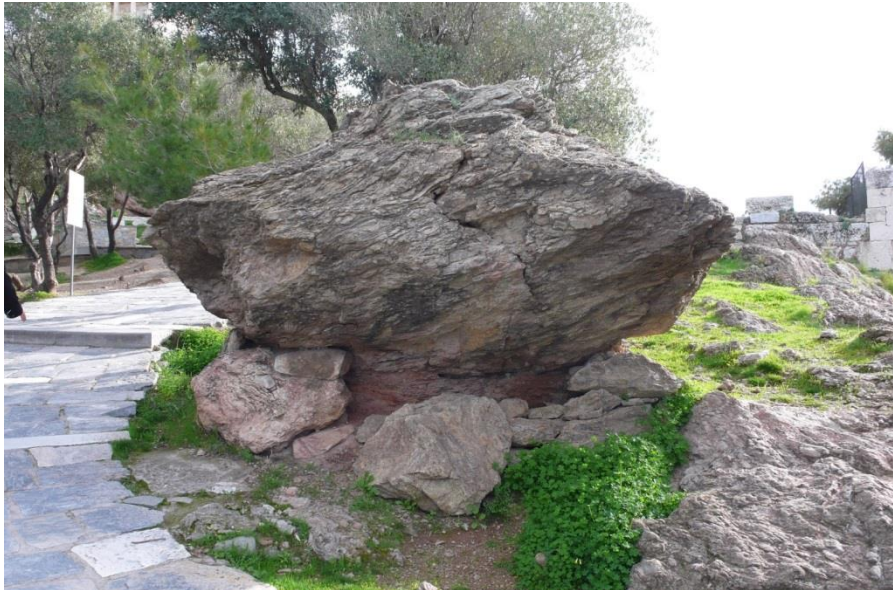
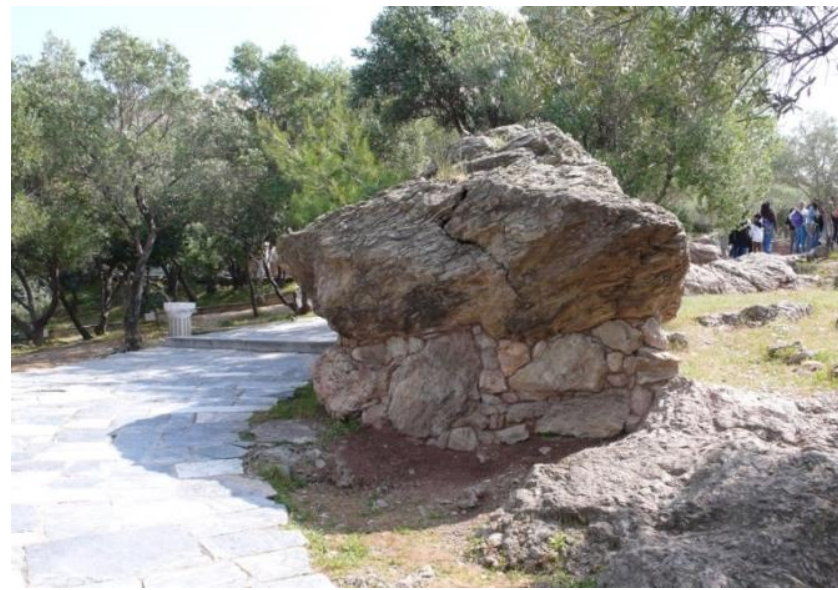
Before and after the works of stabilization of the schistolithic SW slope of Acropolis
