# CLIMATE CHANGE IMPACTS ON CULTURAL HERITAGE: FACING THE CHALLENGE

International Conference  
June 21-22, 2019  
Athens, Greece

Project coordinator:  
**Giuseppina Padeletti**  
(CNR, Italy)

## HERACLES Project: Mission and Vision to face the CC challenge

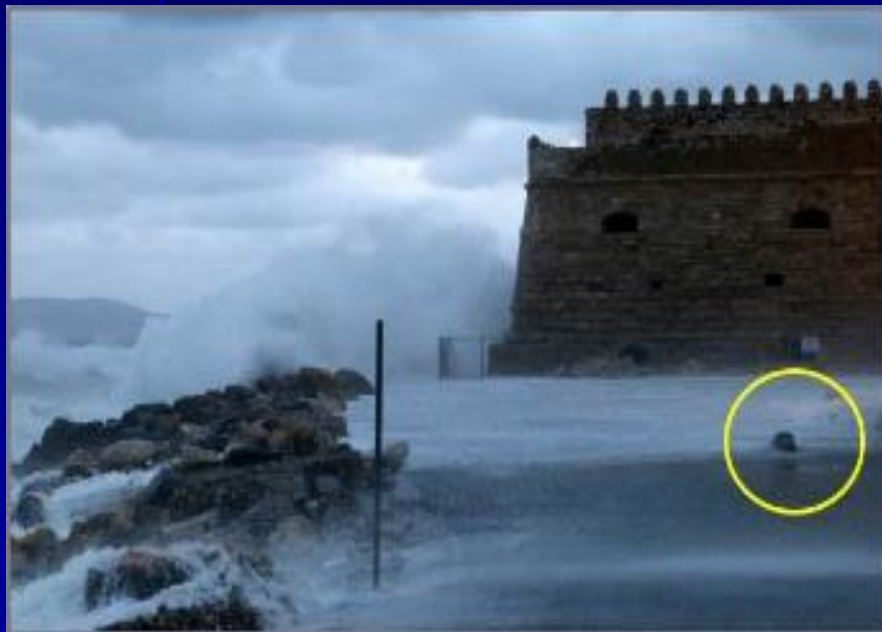
**Example of structural risks due to the impact of big pieces of rock (highlighted in the yellow circle) from the breakwater structures upon intense wave events**

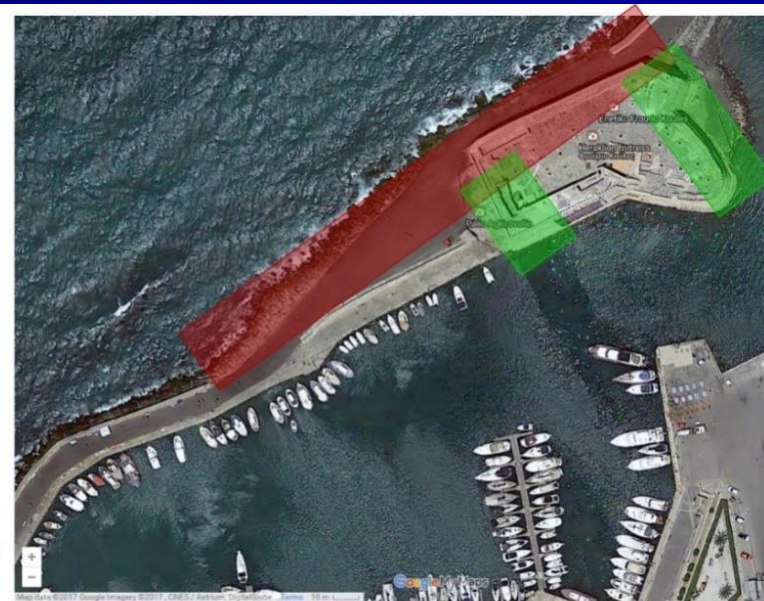
Points of Interest on the basis of structural issues, Fortress of Koules

- a) Sea-wave impact
- b) Areas with structural issues

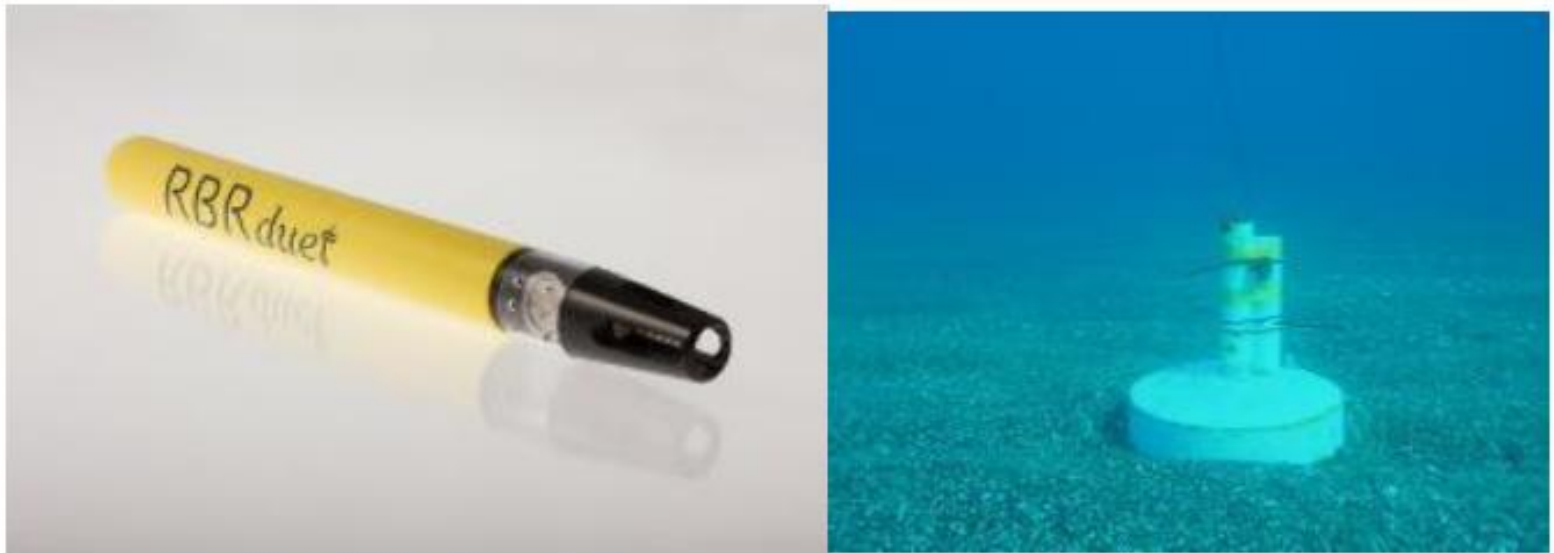
Figure 26: RBRduet sensor (left) and example of an installation base (right).

Wave gauges measuring water level and sea temperature, deployed under the sea in front of the Koules fortress

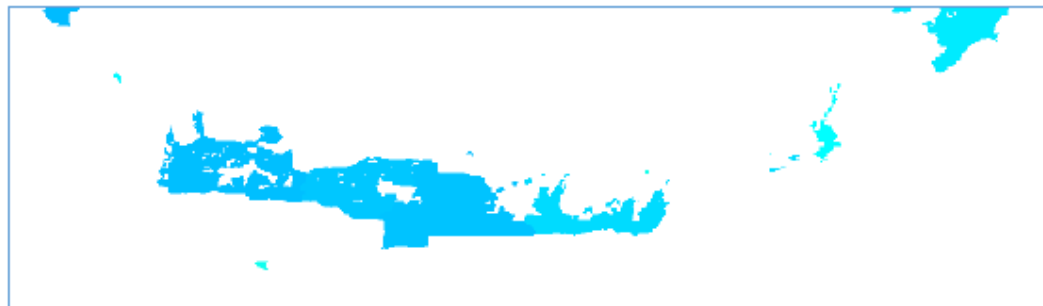
Multispectral sensor Product - Image (Air temperature)

Multispectral sensor Product – Time series (Air temperature)  
air temperature 2014 heraklion

Figure 4: Downloaded image (colours are indicative of the spatial distribution of the temperature) and time series products of air temperature

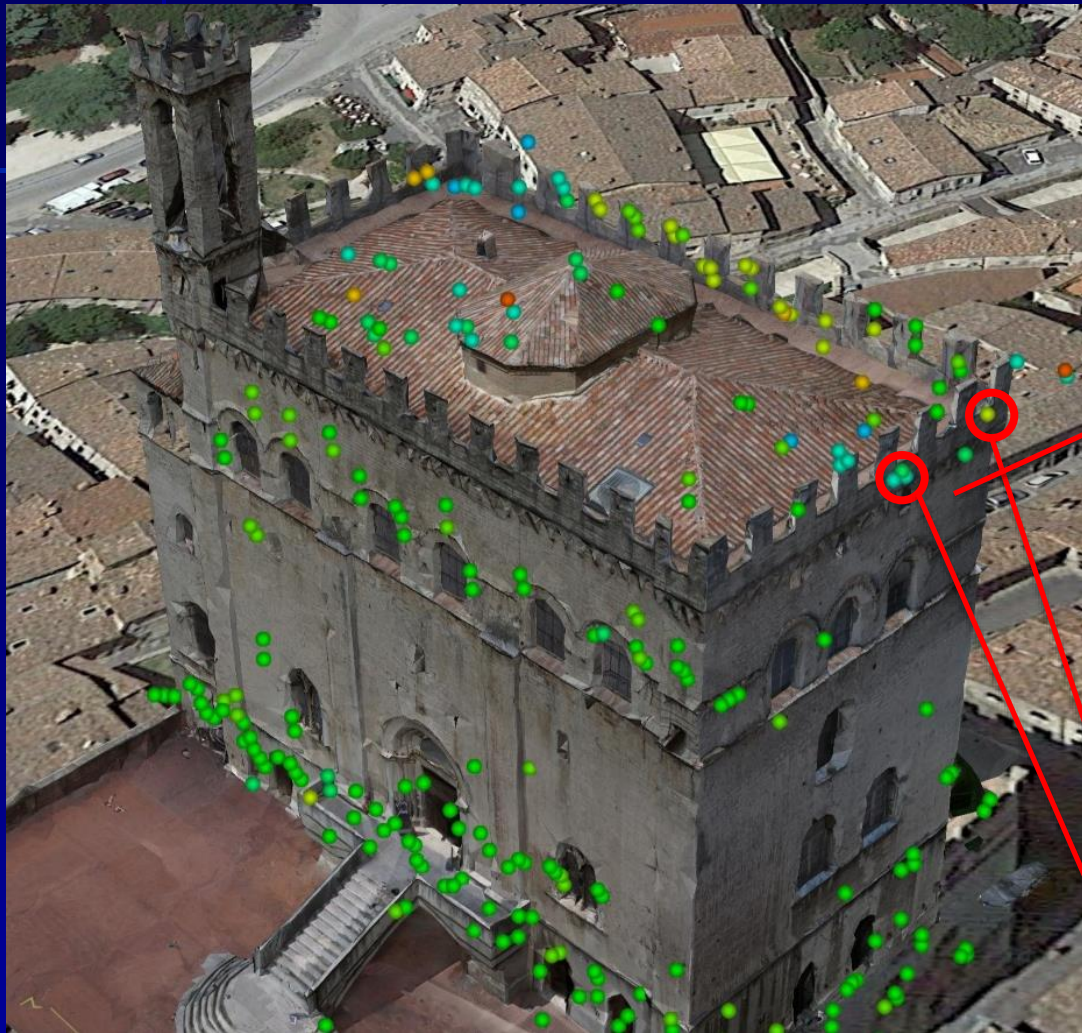
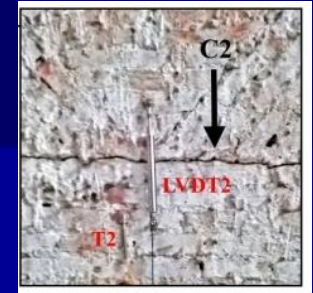
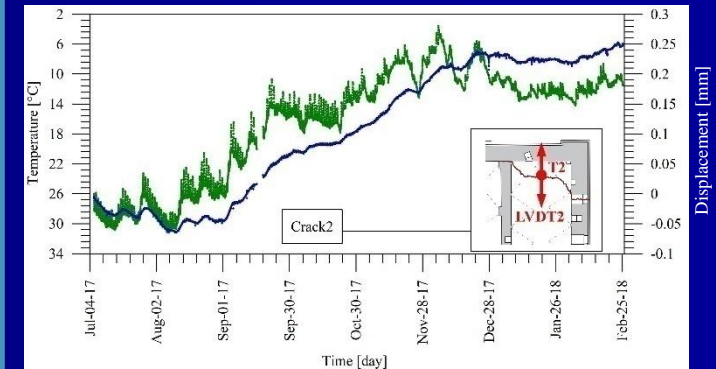
# In-situ data and SAR analysis Comparison Crack 2

*Opening of crack in Autumn/Winter season*

W – West side of crack

E – East side of crack

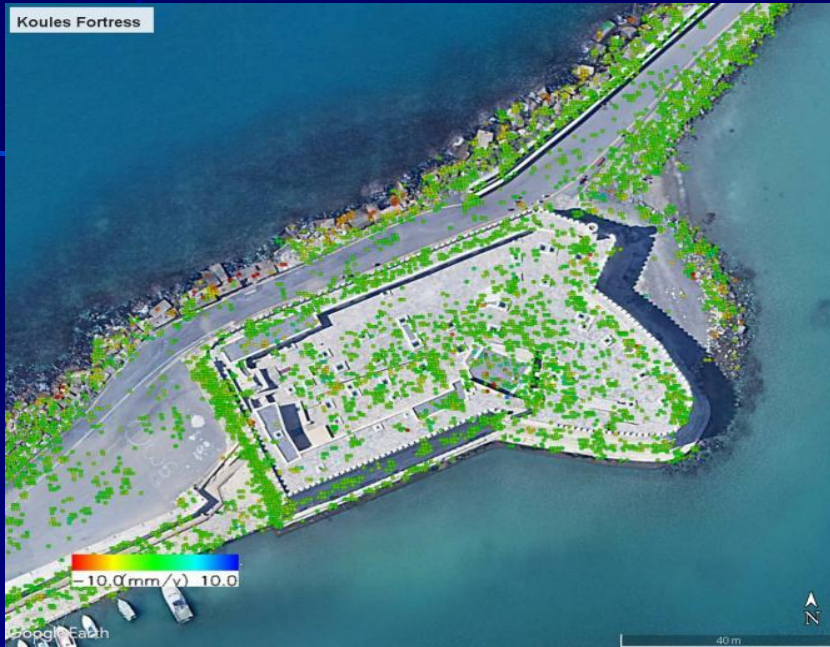
Displacement of breakwaters in the Koules area

**Over Crete: +2.2°C in the near future and + 4,2° far future and decrease of annual precipitation (-12,3% till 2065 and – 28,7% till 2100). Due to changes in frequency and directions of wind and waves in the area, the displacement of the break water and salt spray, are expected to increase**

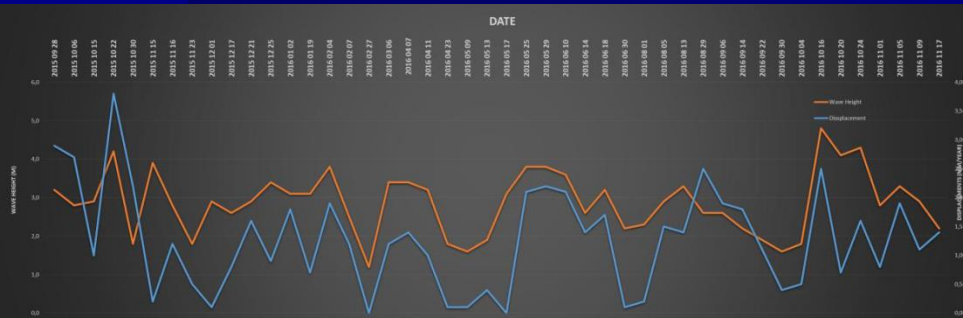
Correlation of displacement with wave heights  
**e-geos, FORTH-IACM**

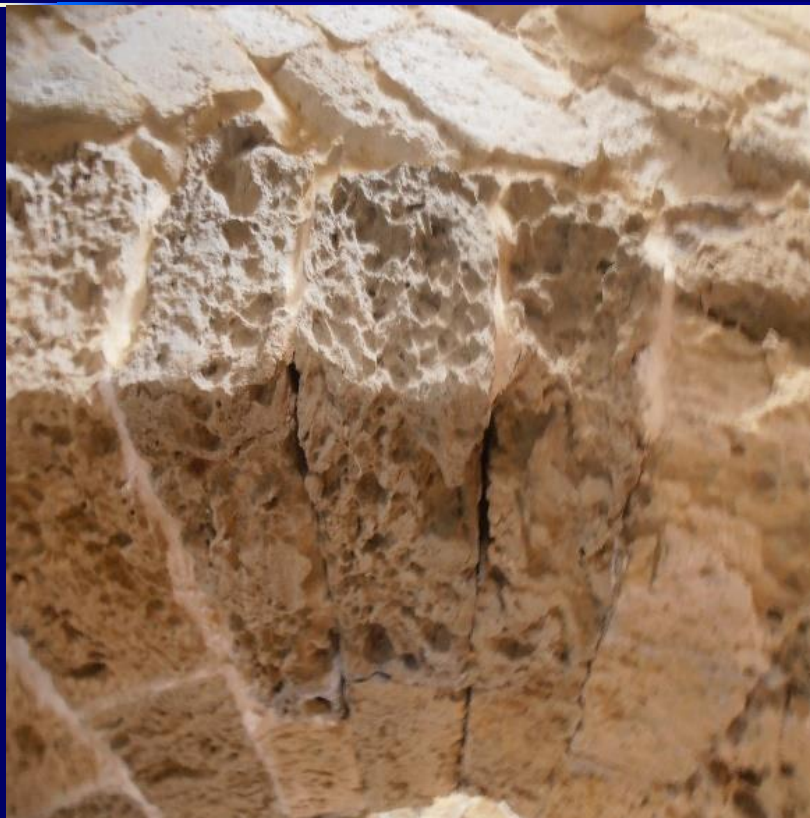
## Materials degradation phenomena Φαινόμενα υποβάθμισης υλικών

Climate Change effects  
Επιπτώσεις Κλιματικής Αλλαγής :  
Koules fortress

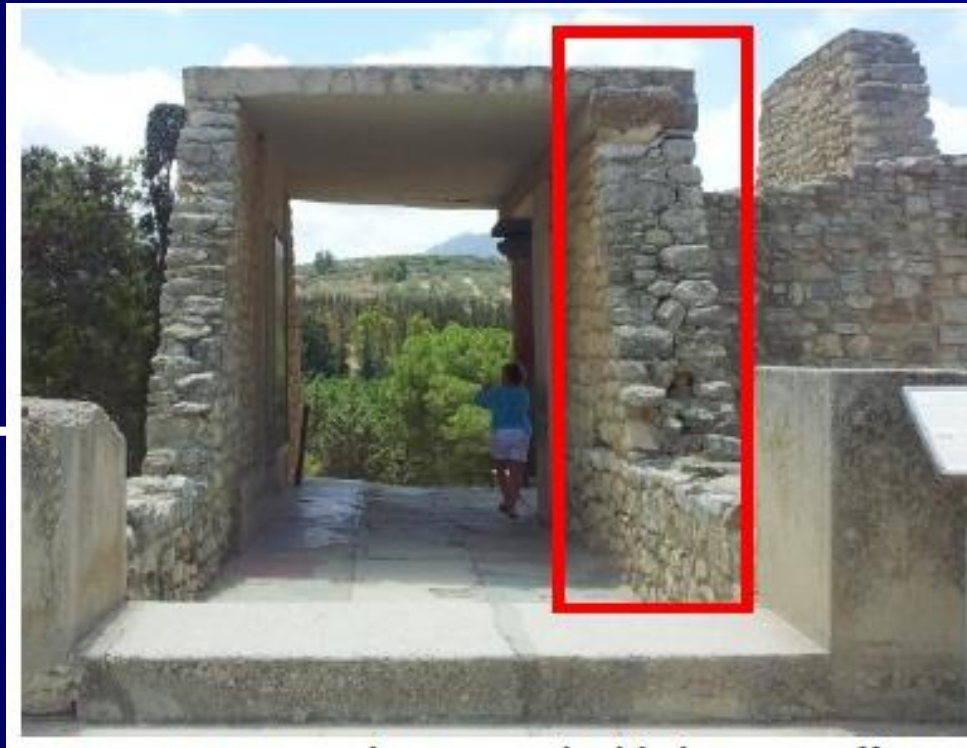
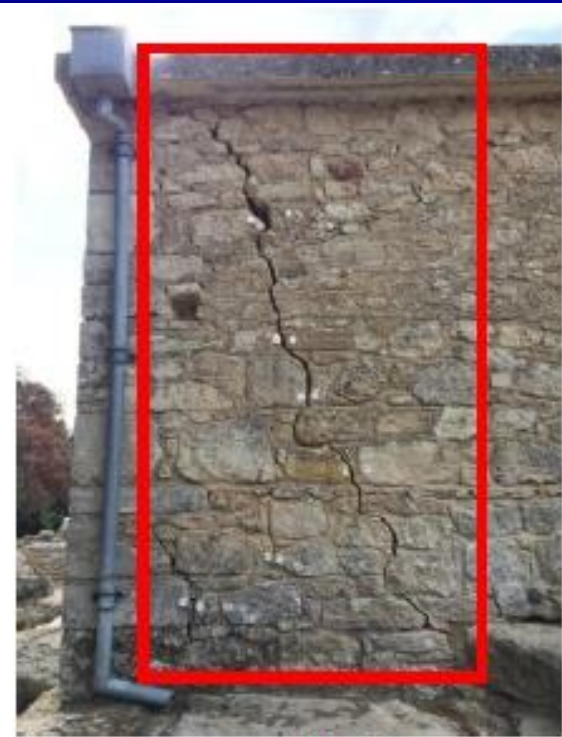
Example pictures highlighting **insufficient bonding between stone blocks in masonry elements** (left) and **major cracks** most likely associated to settling of the foundations (right)

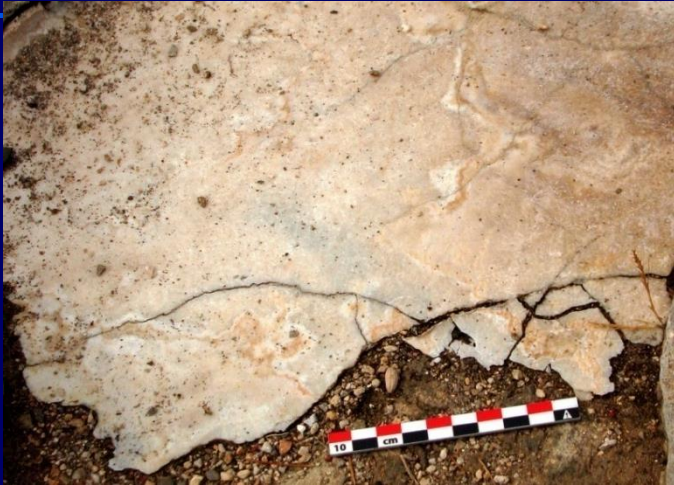
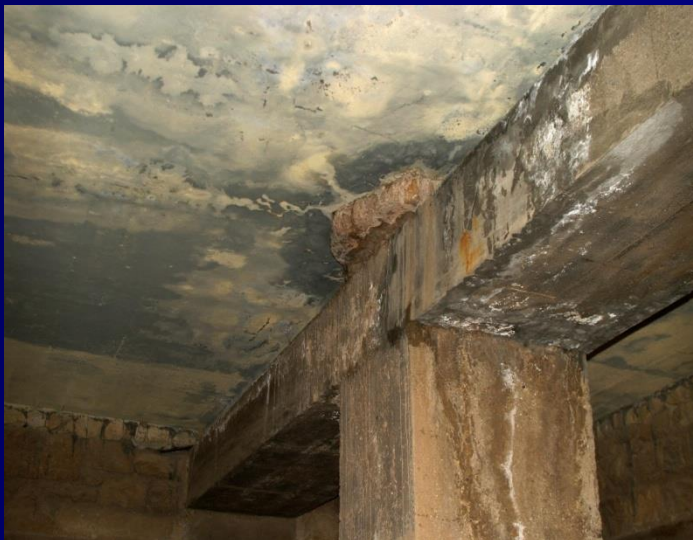
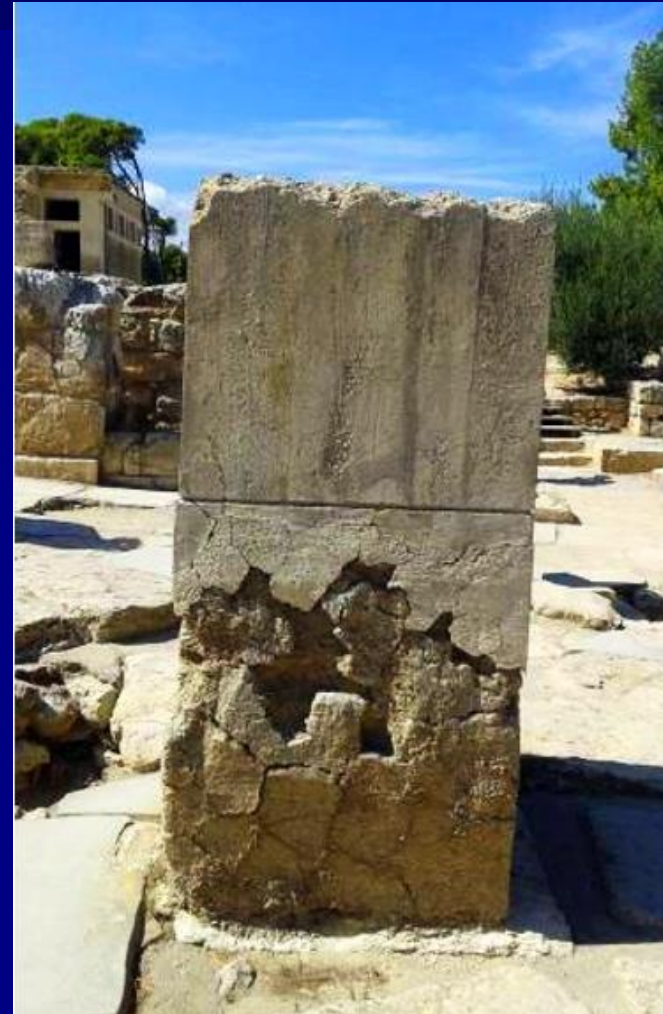
## Materials degradation phenomena Φαινόμενα υποβάθμισης υλικών

Climate Change effects  
Επιπτώσεις Κλιματικής Αλλαγής:-  
Knossos palace

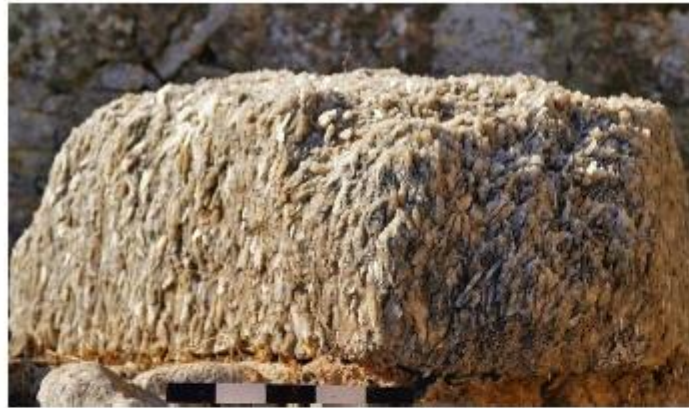
85

Figure 85: Disintegration; Loss of cohesion between gypsum crystal aggregates leading to crumbling. Selenite block located near the "West Magazines", Knossos Palace.

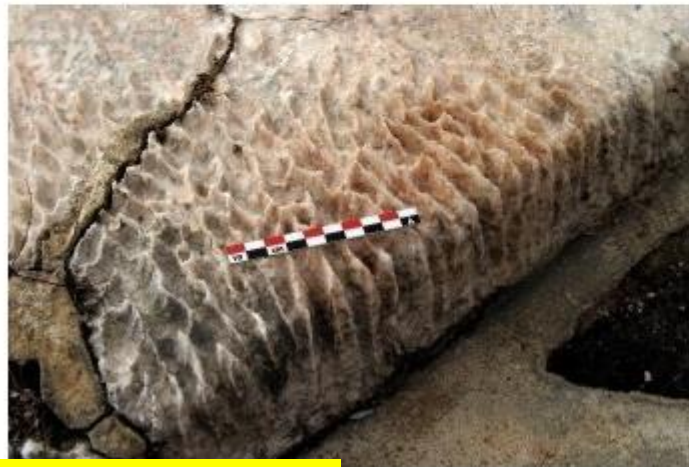
Figure 86: Erosion; Typical formation of microkarst cavities on the surface of secondary gypsum from Knossos. Dissolution pits, grooves and runnels, collectively called karren.

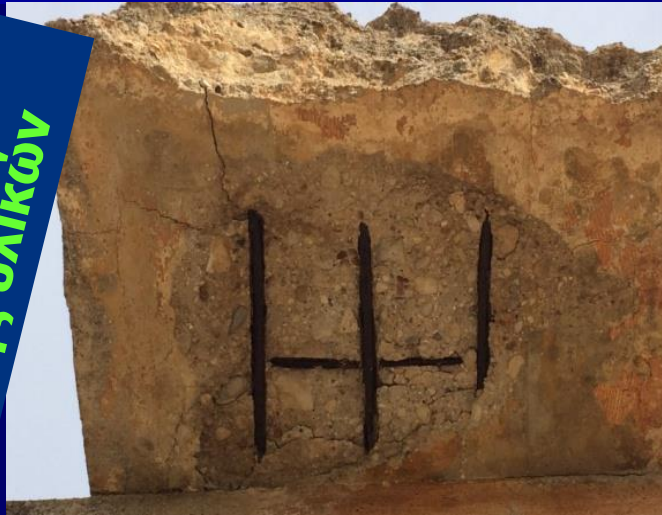
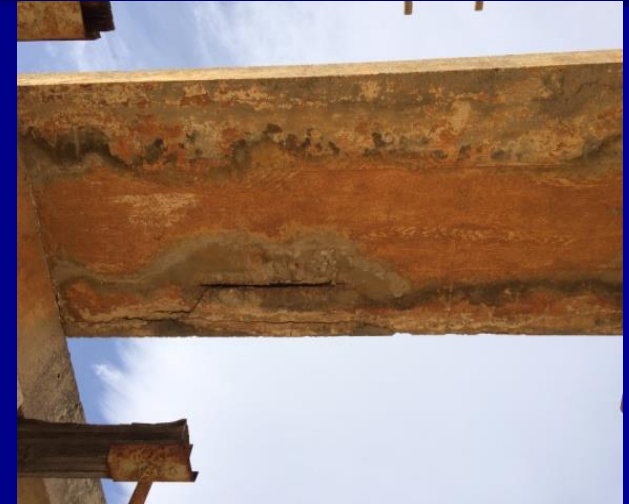
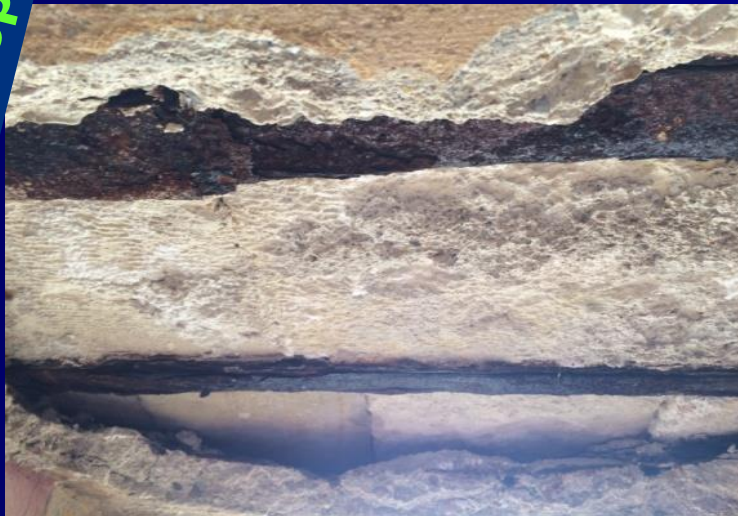
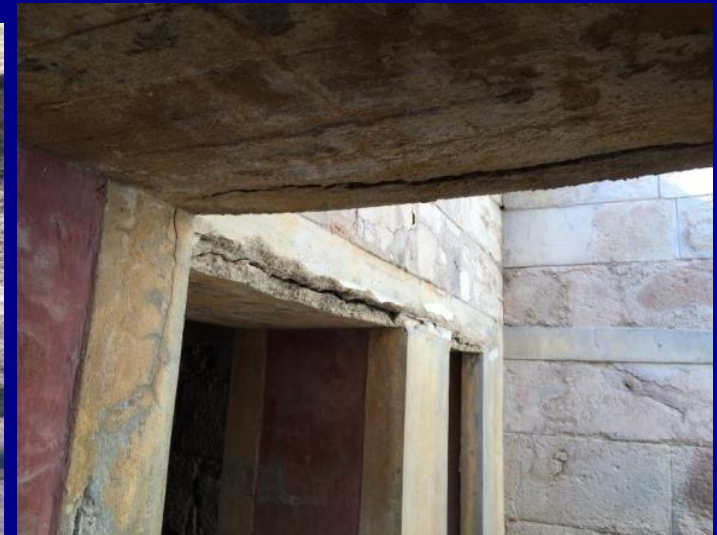
Example pictures highlighting **rebar corrosions in reinforced concrete** elements built during the restoration by Sir Arthur Evans

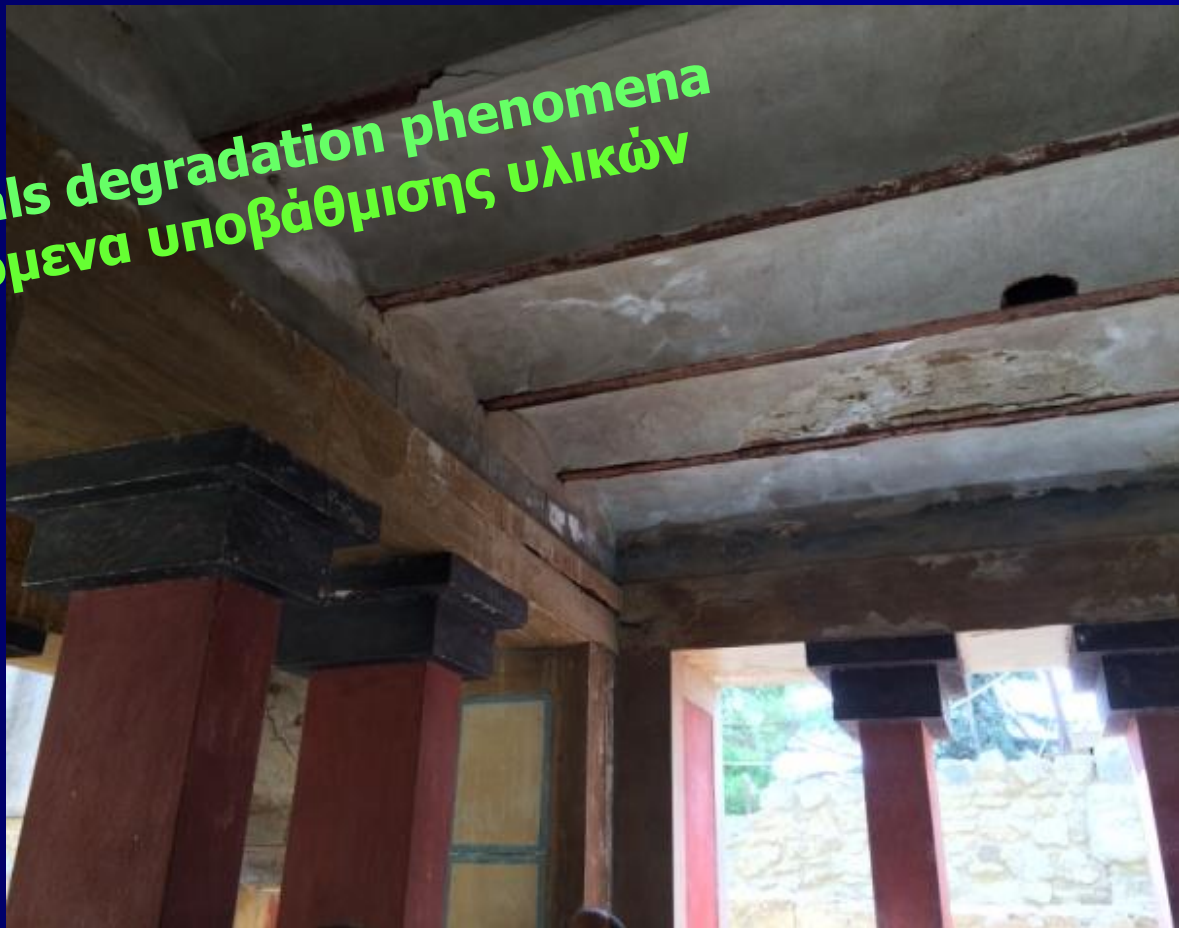
Example pictures highlighting **corrosion of iron beams supporting a floor** with masonry vaults

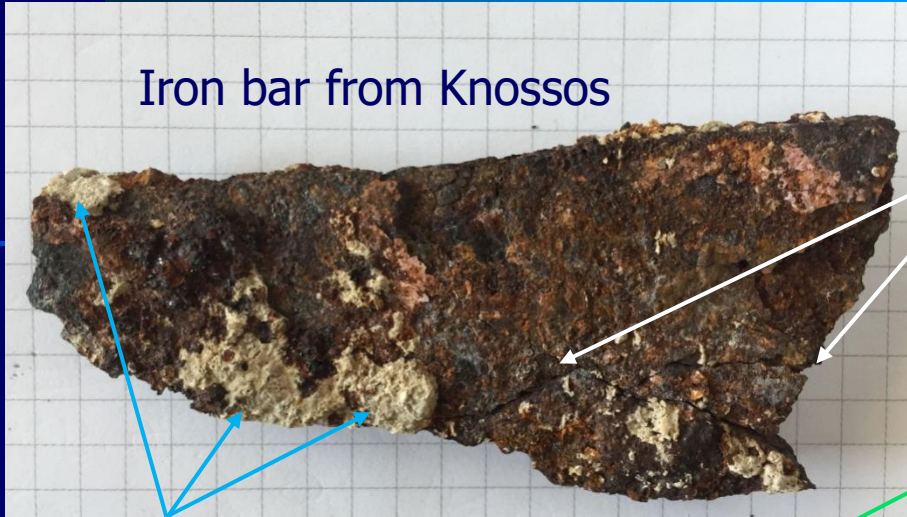
Iron bar from Knossos

Visible cracks

Vertical cracks  
(from the upper  
floor)

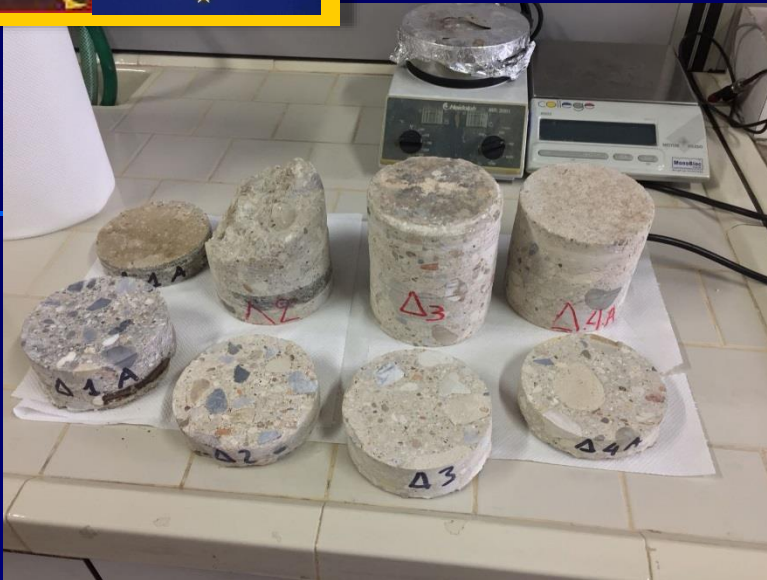
Concrete has been cored in different points

Thin layers (30  $\mu\text{m}$ ) were prepared and observed under a polarized microscope

- main components are calcite ( $\text{CaCO}_3$ ) and quartz ( $\text{SiO}_2$ )
- a low mechanical strength, both in tension and compression.

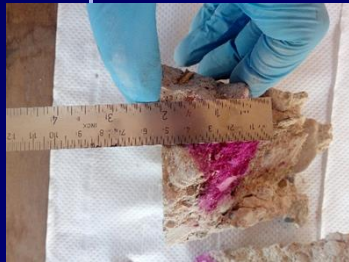
**D 3**

**Porosity**

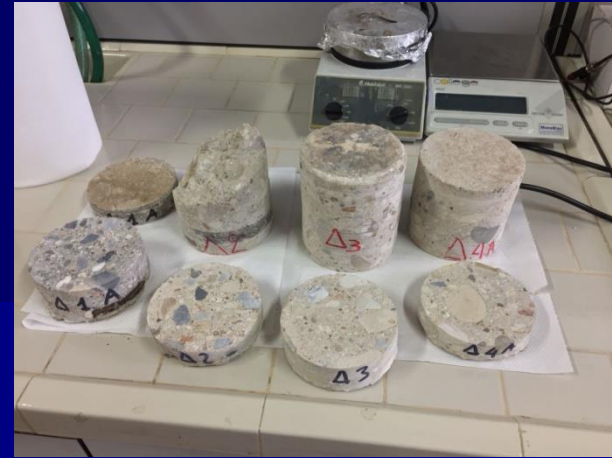
- evaluate the thickness of the carbonated layer with phenolphthalein test.
- for the studied cases the carbonated layer resulted **almost 5-6 cm thick**, evidencing a higher carbonation level exposing the internal bars to corrosion.

**Carbonatation: 5-6 cm !!**

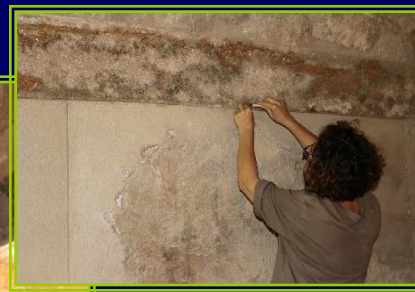
The corrosion cycle of steel begins with the rust expanding on the surface of the bar and causing cracking near the steel/concrete interface. As time marches on, the corrosion products build up and cause more extensive cracking until the concrete breaks away from the bar, eventually causing spalling.

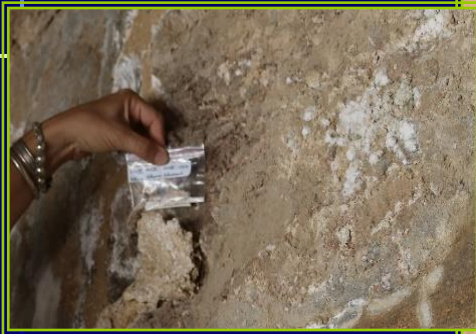
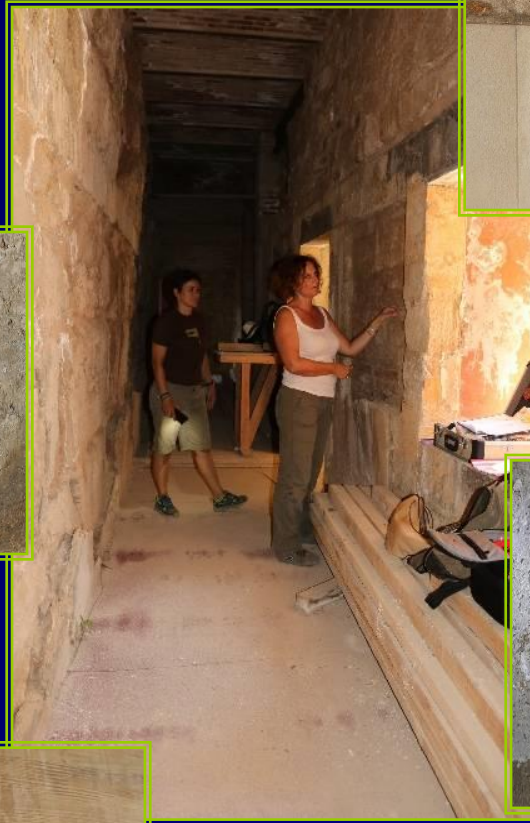
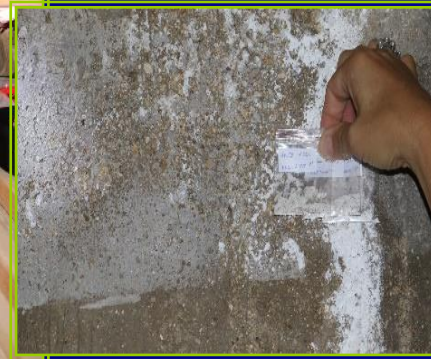
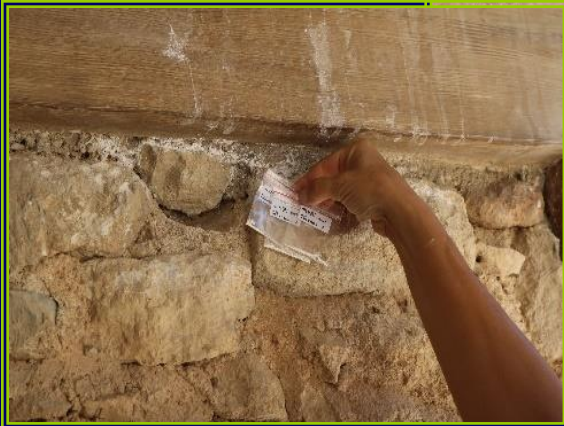
**Measurement campaigns**

Samples of corrosion products were also taken (i.e. crusts and efflorescences) achieve a better understanding of erosion mechanisms and environmental factors (**FORTH-IESL, CNR, UNINOVA**).

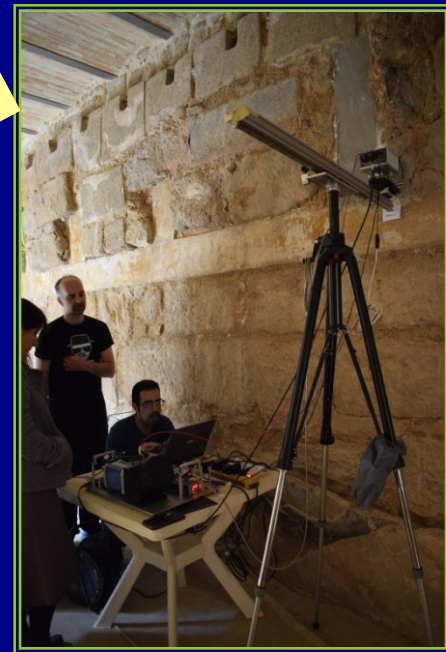
Measurement campaigns

At the same time measurements were carried out using portable instruments: Multispectral Imaging system, LIBS, Raman (**FORTH-IESL**)

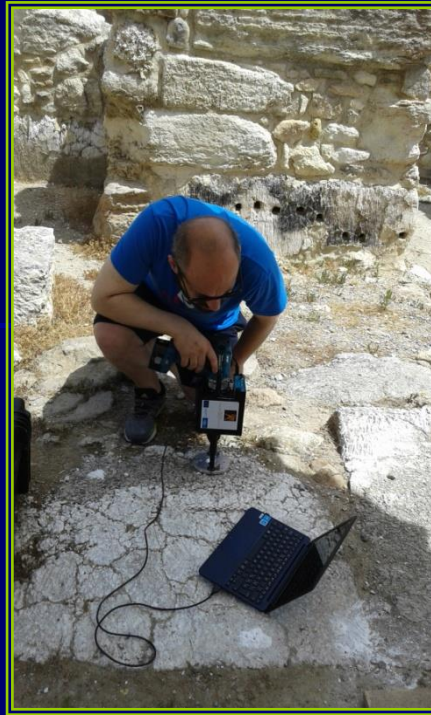
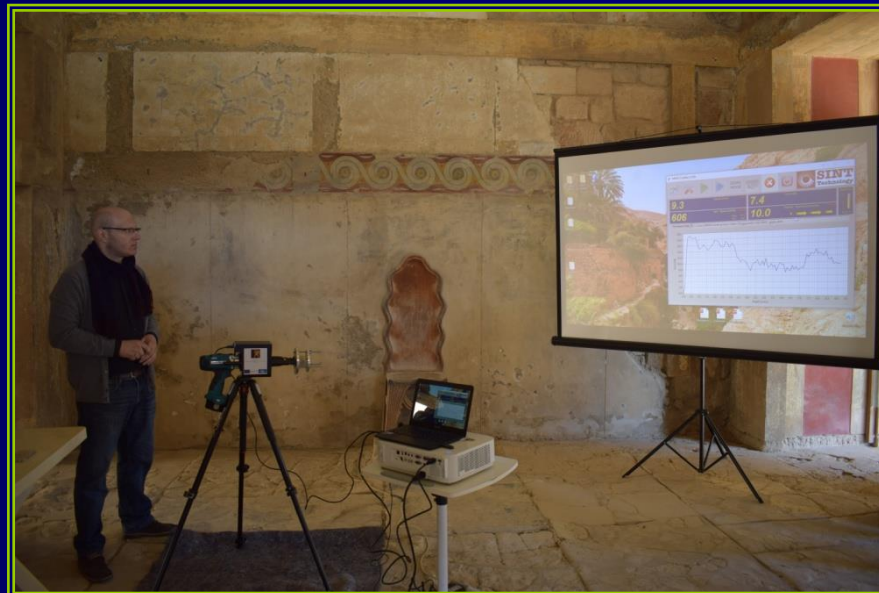
Special attention is given to **mineral gypsum** (selenite): Research is focused on the design and development of an innovative consolidant, which will guarantee highest durability, reversibility and compatibility for gypsum (**UoC**).

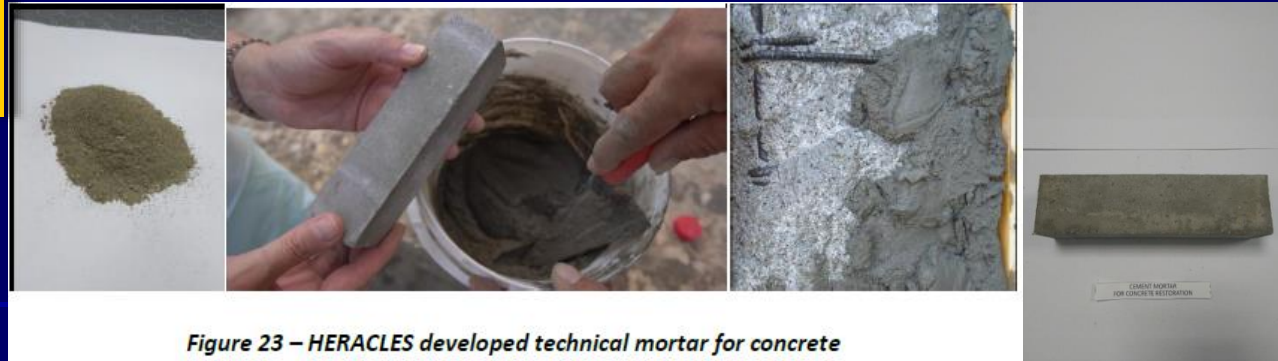
Figure 23 – HERACLES developed technical mortar for concrete

✓ *Cement mortar, reo-plastic, polymer modified, formulated with sulphate resistant cement (SRC) binders*

✓ *Cement mortar with high compressive strenght, adequate elastic modulus*

✓ *Cement mortar with reduced CO<sub>2</sub> permeability*

✓ *Expressly developed to restore old structures in reinforced concrete, also showing an advanced deterioration degree*

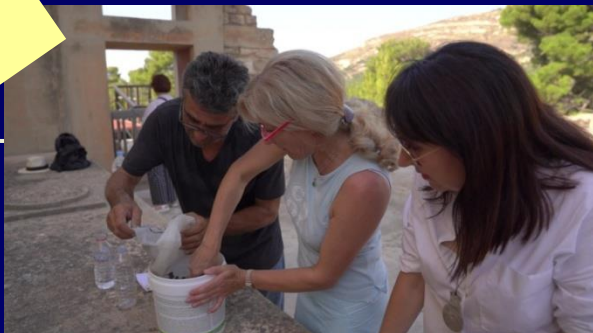
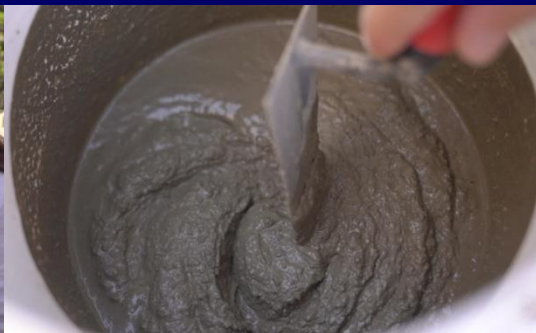
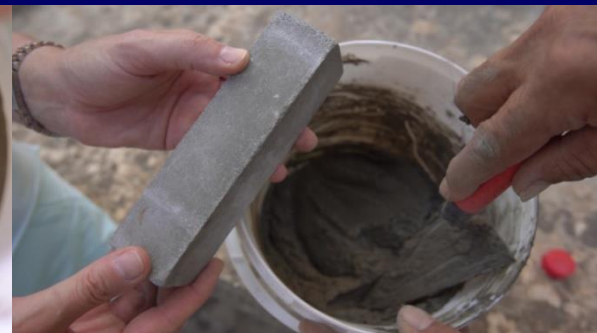
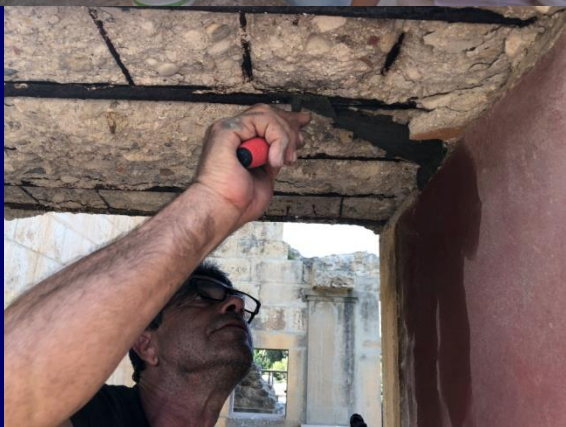
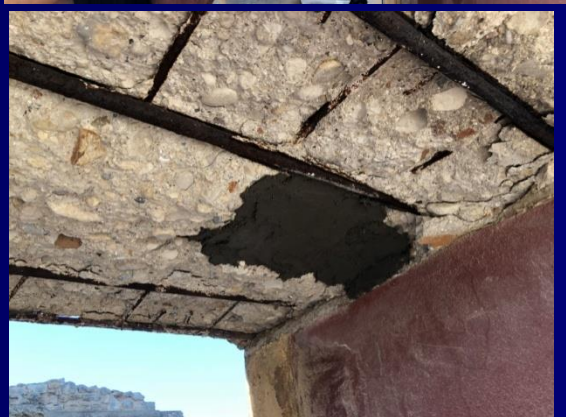
# New proposed Solutions – Cement Mortar

**Trials**

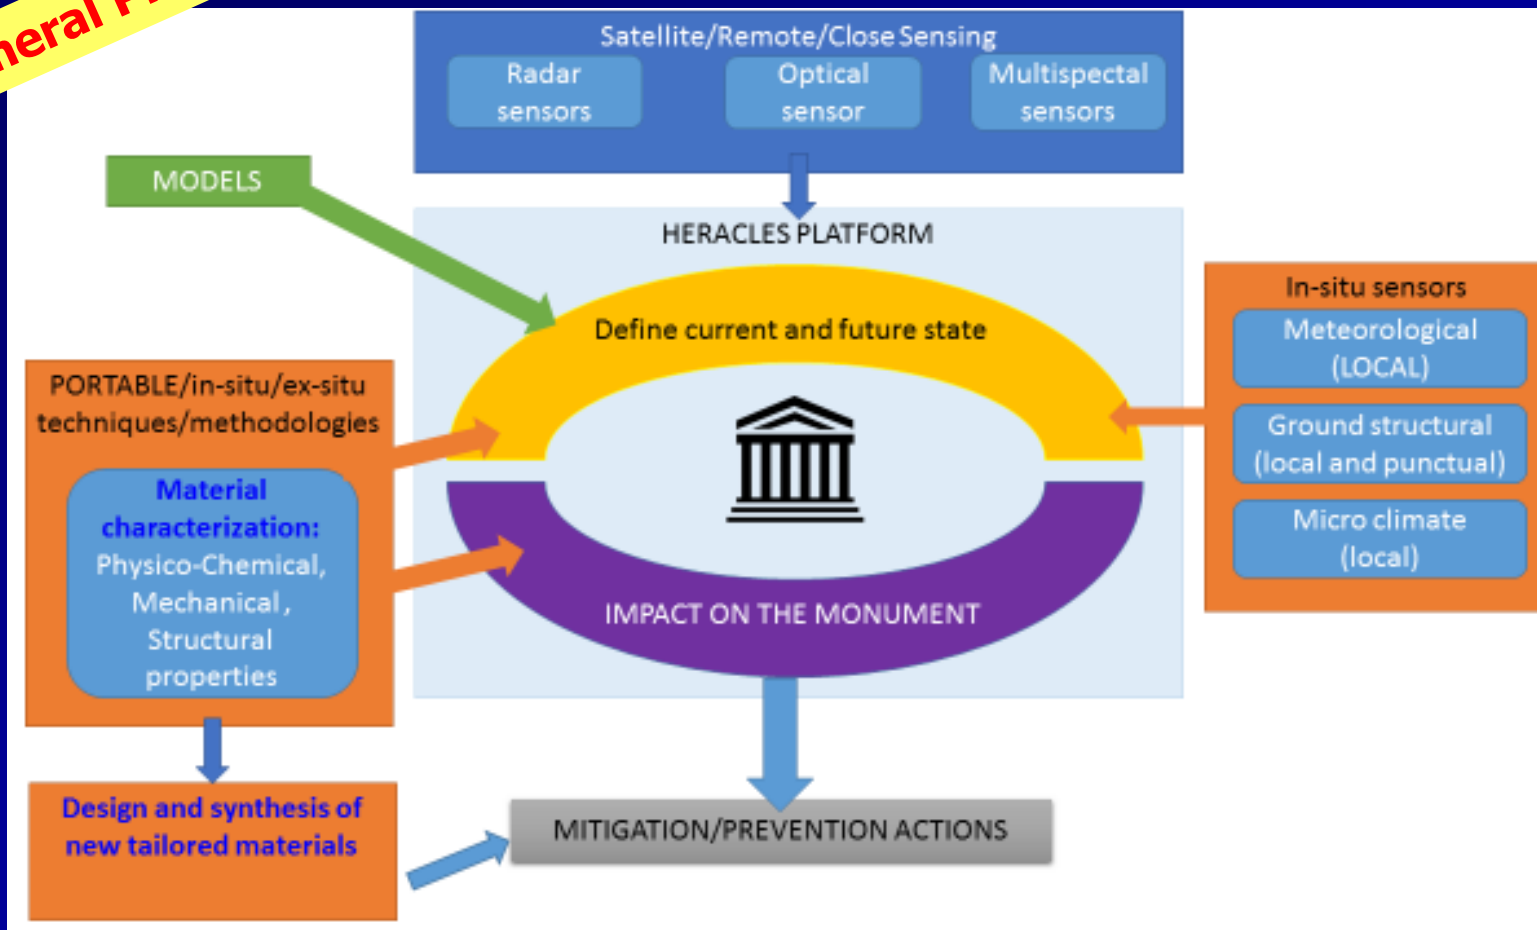
**General Protocol**

## Schematic representation of the **HERACLES general protocols approach** as regards the sensing, diagnostic and analytical strategies.

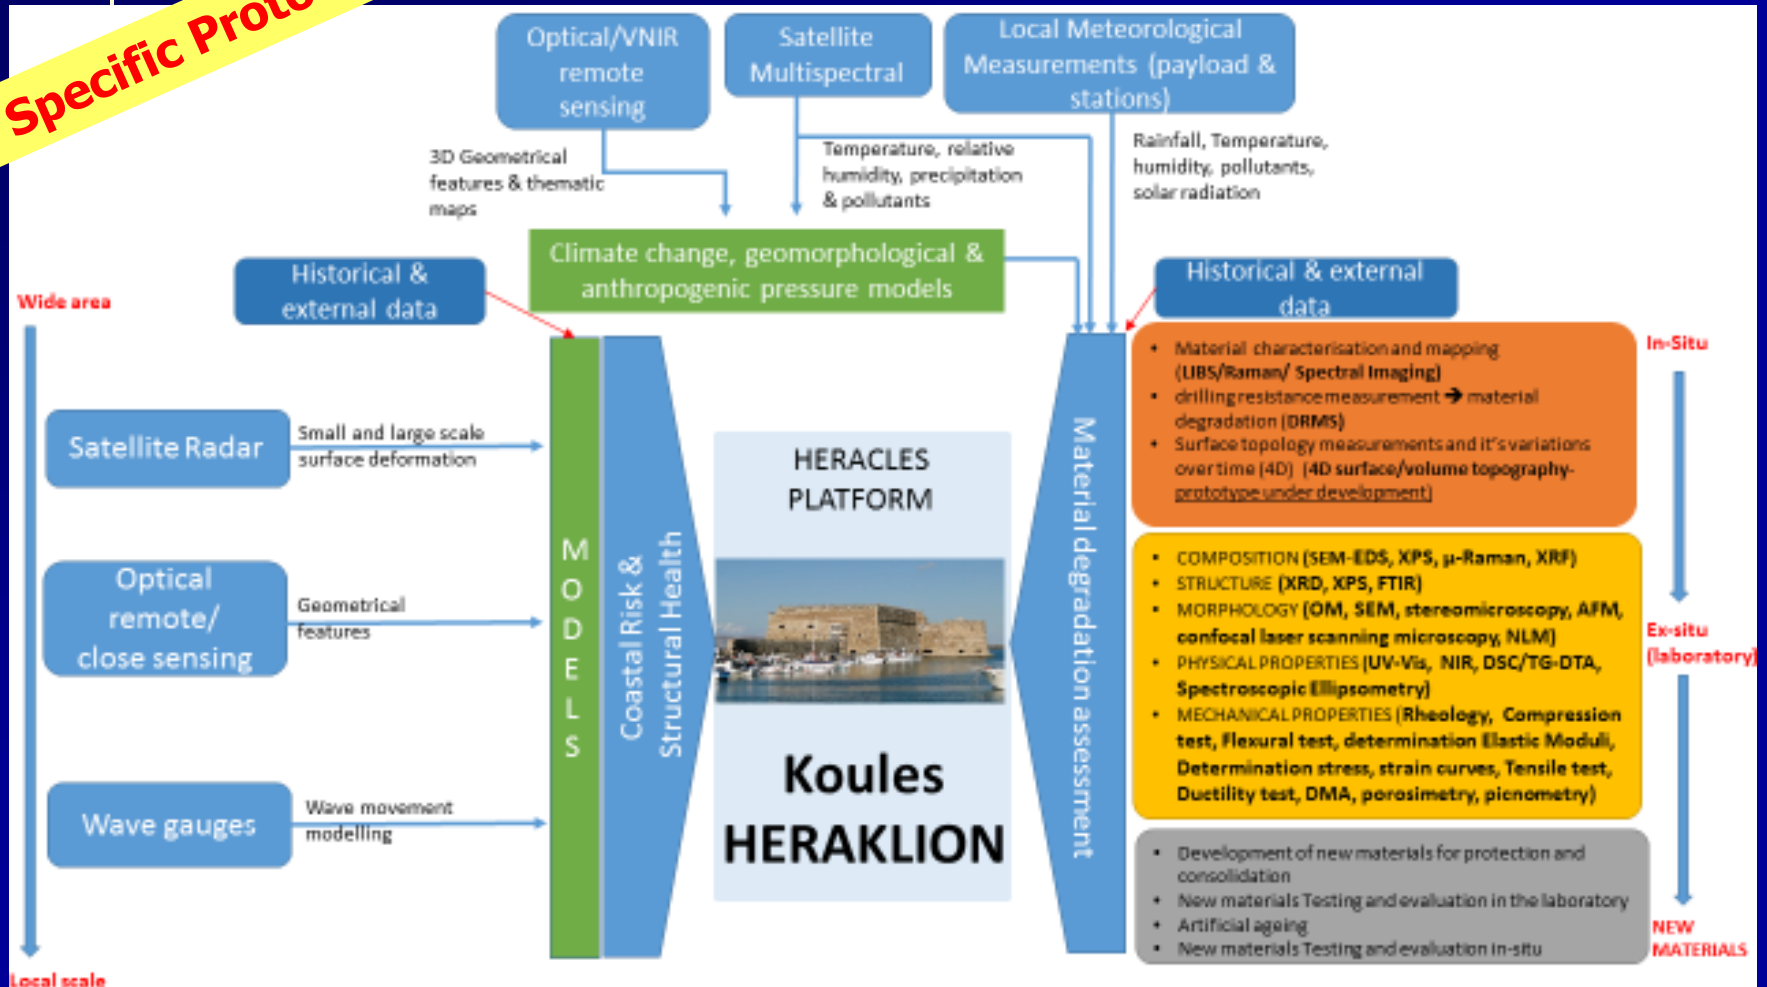
## Systematic protocol Koules Fortress

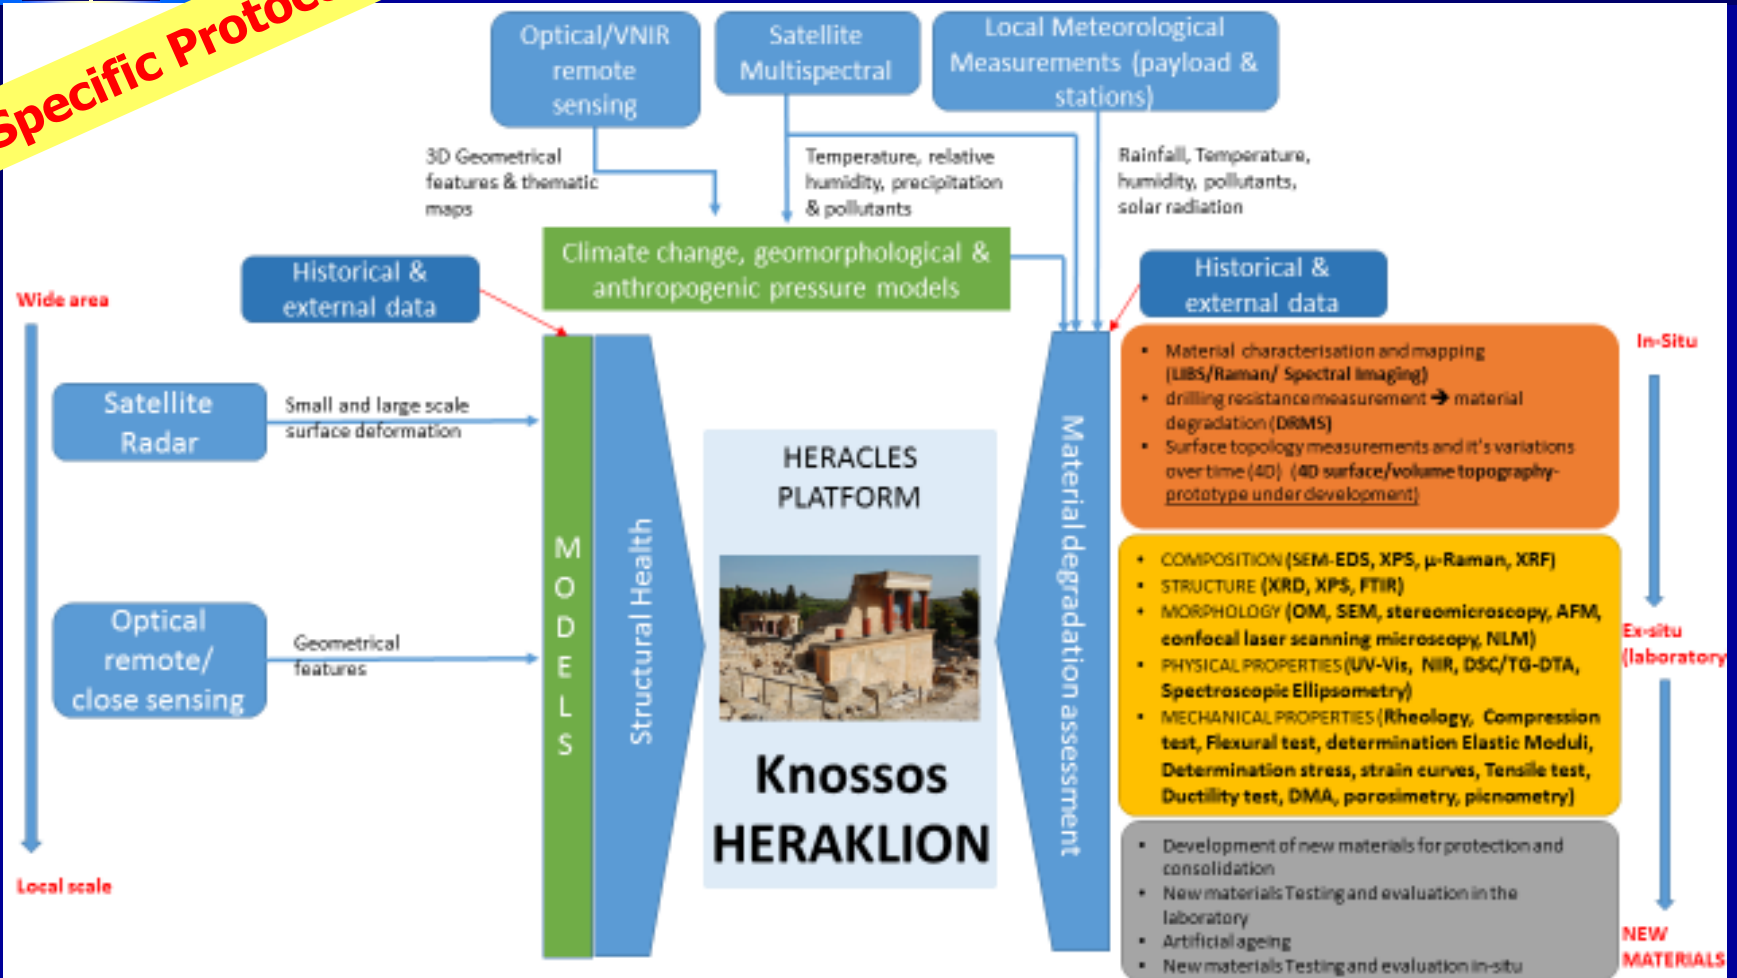
## Systematic protocol Knossos Palace
