Strengthening Cultural Heritage Resilience against the impacts of Climate Change: the case of Cyprus

Toolbox for assessing and mitigating Climate Change risks and natural hazards threatening cultural heritage

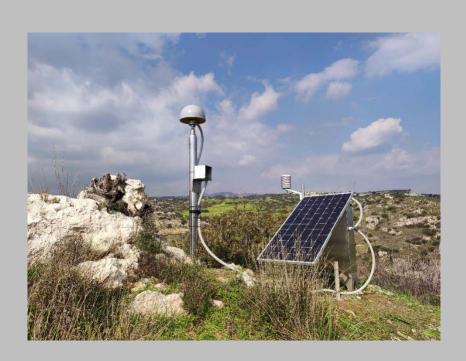
One (1) GNSS Seismic Mobile Station has been installed to the highest point of the site, in order to achieve maximum accuracy during measurements provided by the International GNSS Service (IGS) and EUREF's Permanent Network (EPN).

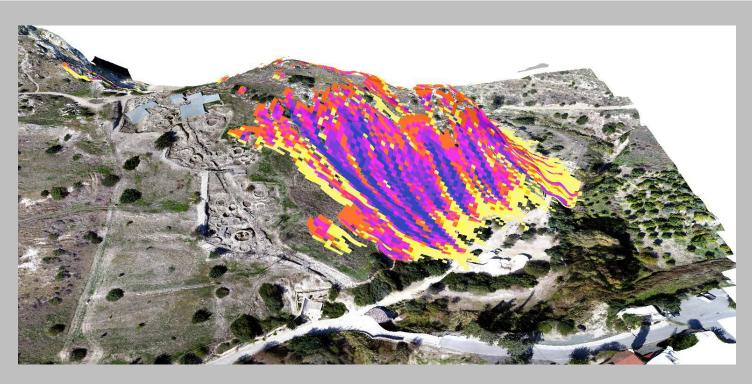
Preliminary HY- STONE Rockfall Analysis of Choirokoitia

The rockfall runout simulation was performed by using the 3D model Hy-STONE (Agliardi and Crosta, 2003; Crosta et al., 2004). 3D models are able to simulate block motion along a slope by including lateral dispersion of trajectories due to large and small scale morphological complexity (Descoeudres and Zimmermann, 1987: Guzzetti et al., 2002; Agliardi and Crosta, 2003; Crosta et al., 2004; Dorren et al., 2006).

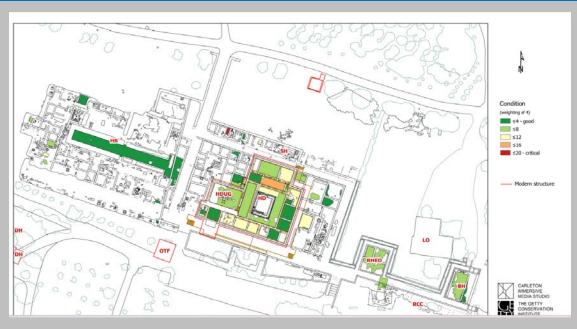
Condition recorded on GIS and established priorities; UNESCO site of Nea Pafos
